Princess Pier, Torquay

Appendix to Capital Scheme Business Case: Princess Pier – Superstructure

A non-technical report primarily concerned with the condition and works need of the pier boardwalk.

July 2017

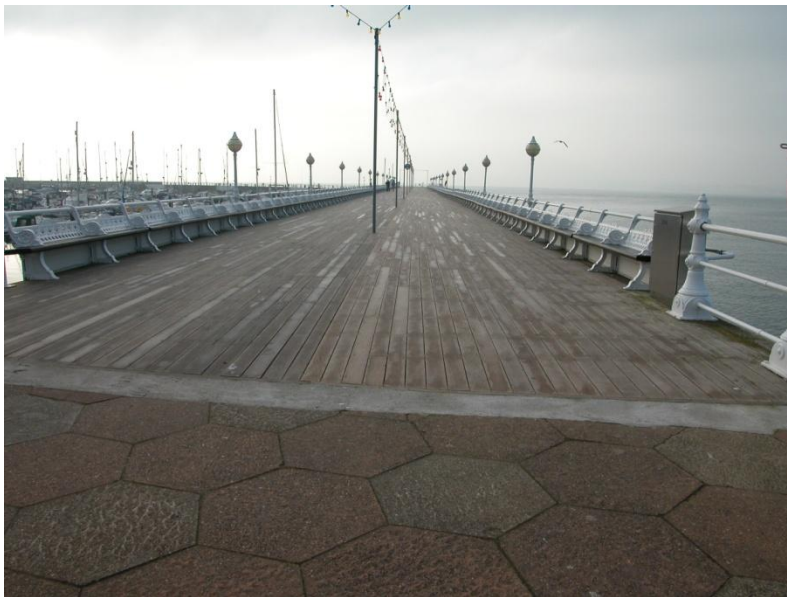
1 *Timber boardwalk at Princess Theatre promenade*

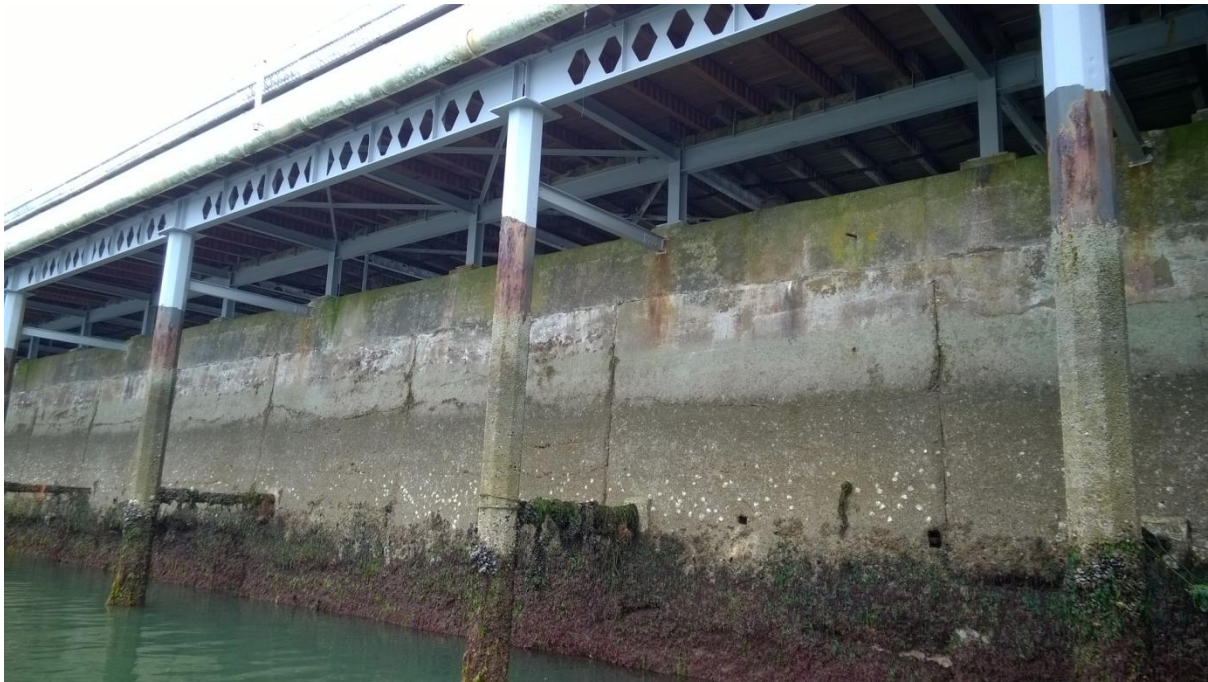
2 1970s-installed galvanised steel frame below timber boardwalk supported on the original concrete and masonry pier, and by steel piles (columns)

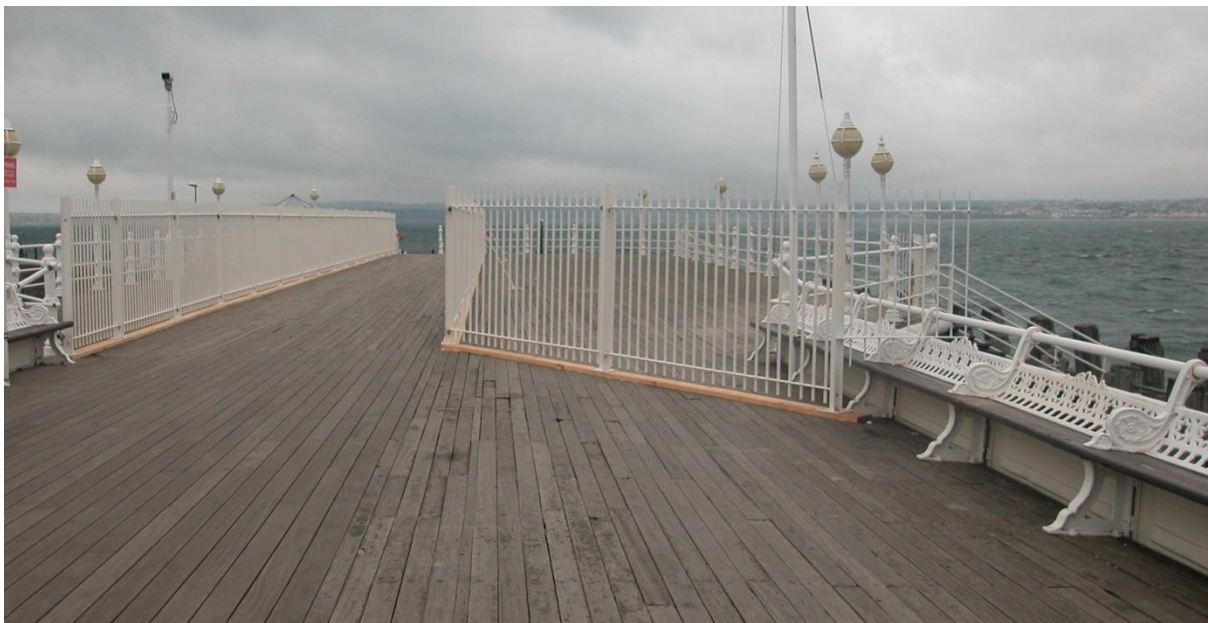
3 Widening at the pier head; fencing installed in 2007 to close unsafe areas, thoroughfare maintained for public access to pier beyond

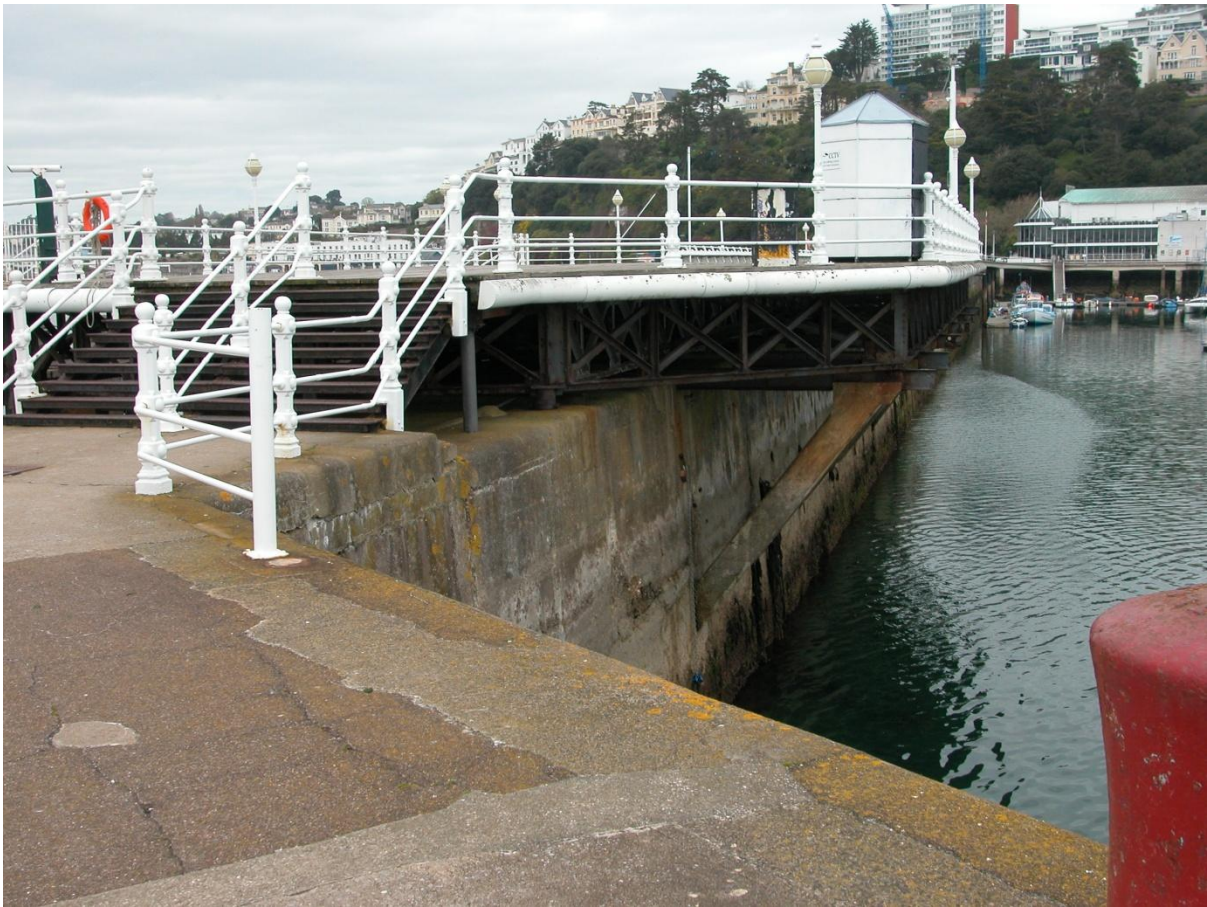
4 1950s-installed steel lattice supported widening stepping down to original concrete pier structure (photo taken before the 2007 closure). Both the steel lattice and the diagonal concrete encased steel props supporting it are severely defective

Meanwhile the 1950s-installed steel lattice spanning over the piles and supporting the timber deck widening continues to similarly deteriorate, it having suffered complete loss of protective coating and having been exposed to the aggressive marine environment for many years. Severe section loss may be observed throughout the full lattice extent, where corrosion has left some elements with little residual structural capacity. The concrete-encased diagonal struts, redundant on the seaward side of the pier, but providing support to the harbour-side widening (see photo 4) display significant spalling i.e. bursting of the encasing concrete, maintaining the enclosed steel increasingly exposed to continuing corrosive action.

The boardwalk widening at the end of the pier (the 'Banjo'), and the timber landing adjacent are at critical risk of collapse. They are recommended to be urgently demolished under controlled conditions since such collapse may otherwise compromise the integrity of the sea defence to which they are attached. Access to the concrete pier beyond the 'step' arising following removal of the widening would be proposed to be returned with a ramped installation, as shown in the drawing below. Demolition and remedial step/ramp install are likely to be subject to Planning consent.

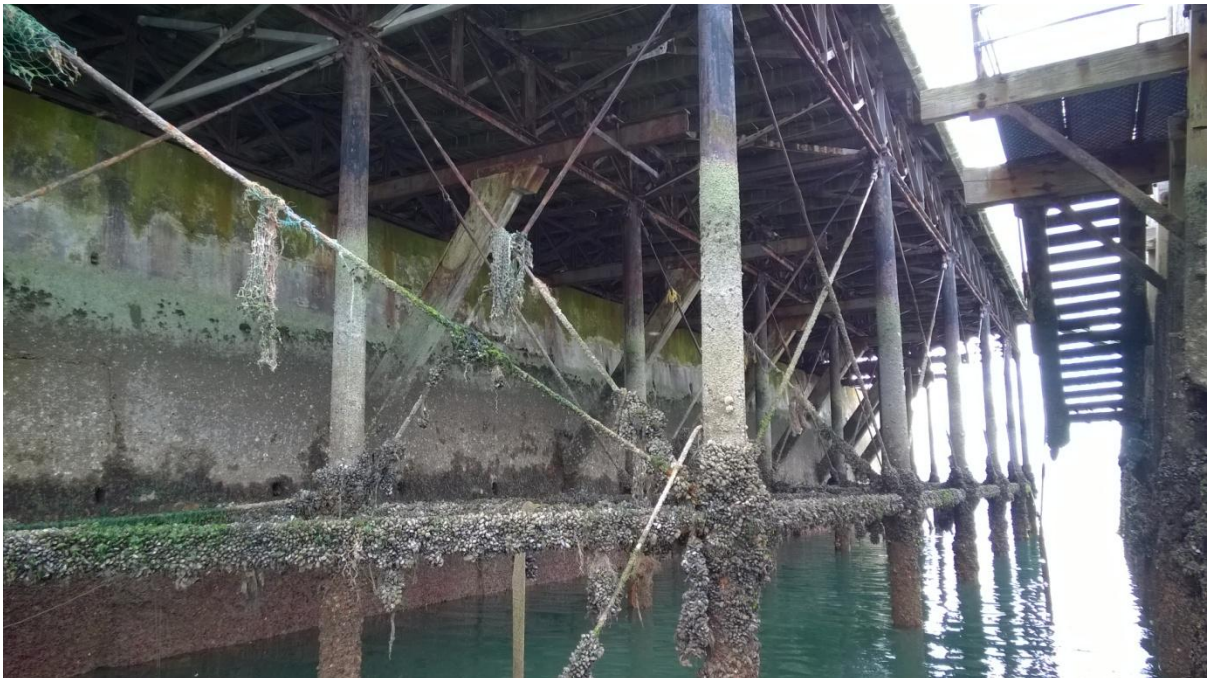
Reported in 2007 the steel piles supporting the lattice framed widening have been measured to be losing an average 1mm section thickness per year at the zone of 'Accelerated Low Water Corrosion' (ALWC). They were in the report estimated to lose all section thickness at this aggressive zone within 15 years. The piles currently therefore appear to be very close to failure. In addition their diagonal ties have in some cases already deteriorated to failure. ***The cumulative effect of severely weak piles and failed ties leaves the supporting***

members to the boardwalk widening as offering extremely uncertain structural stability.

5 Piled support to boardwalk widening showing failure of diagonal ties. The piles supporting the lattice framing have suffered accelerated low water corrosion (ALWC) and are severely corroded, having lost an average 1mm section thickness per year. The timber landing is to the right of the picture

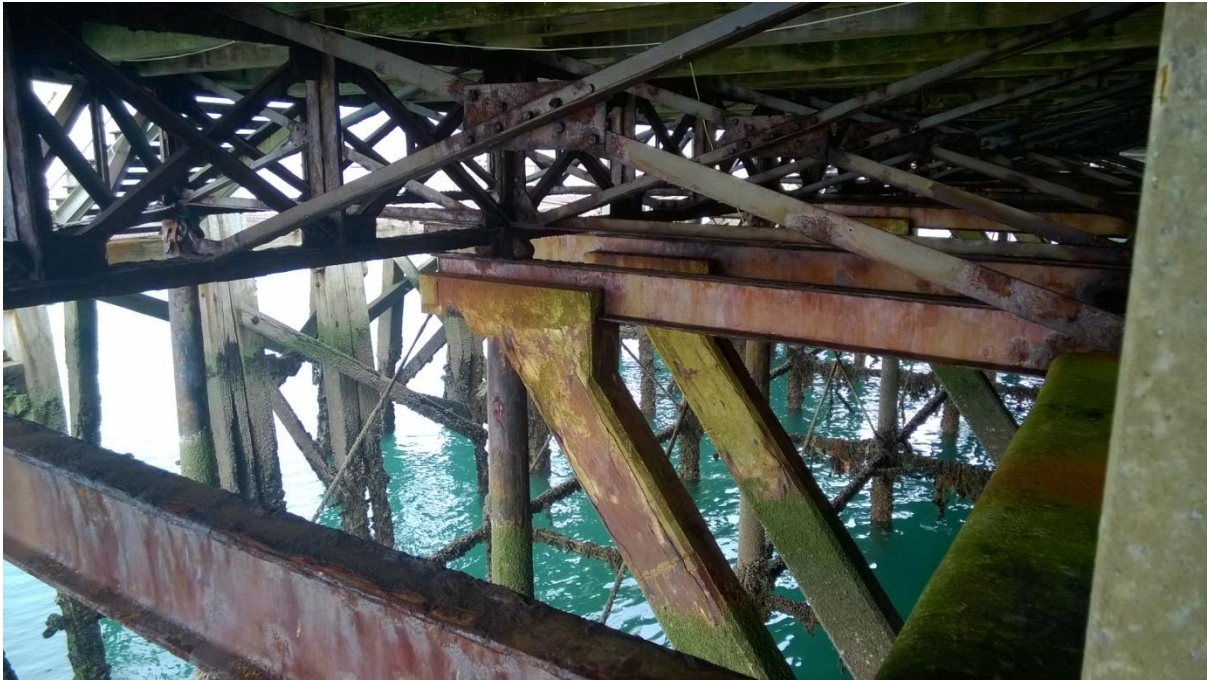
6 General view below pier head widening showing corrosion to steel framing and significant spalling (cracking) of concrete encased props

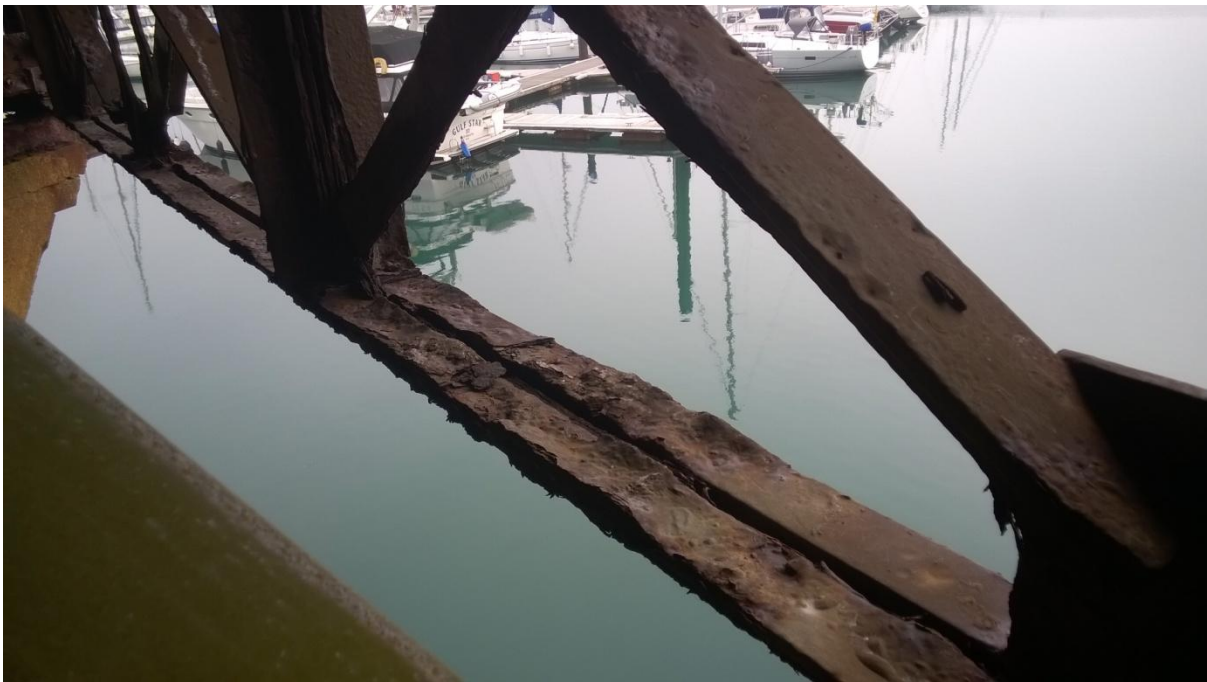
7 Heavy corrosion to pier head steel lattice

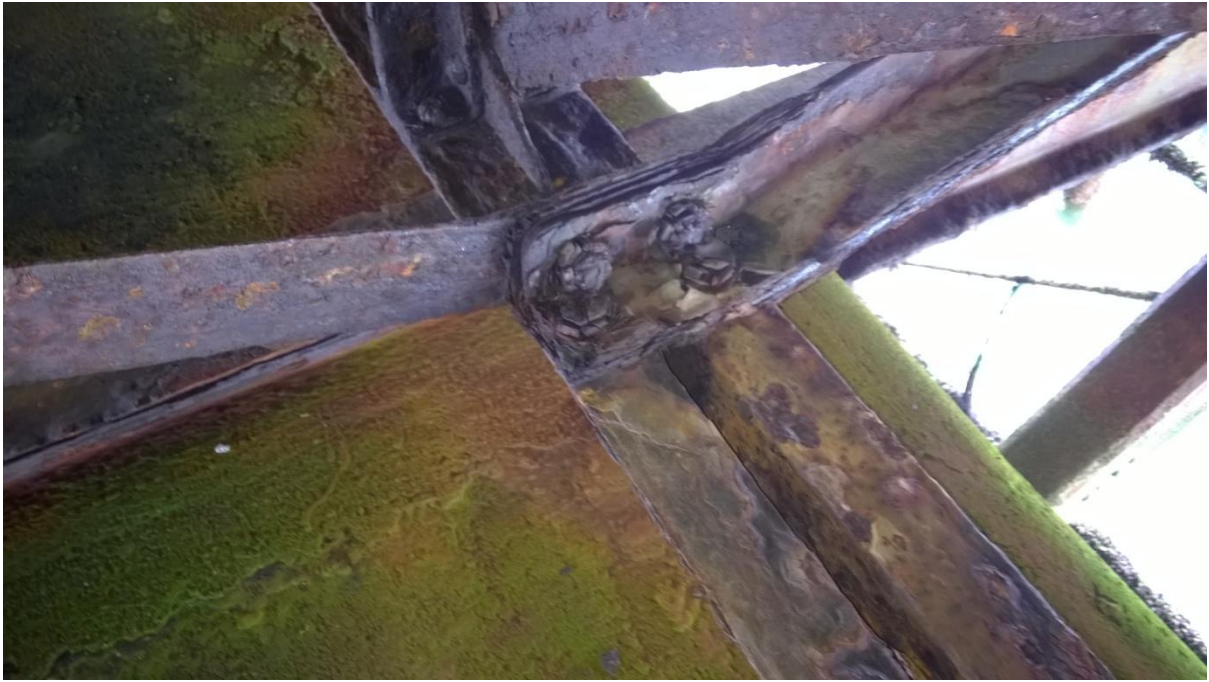
8 Heavy corrosion to pier head steel lattice, showing delamination over residual steel section

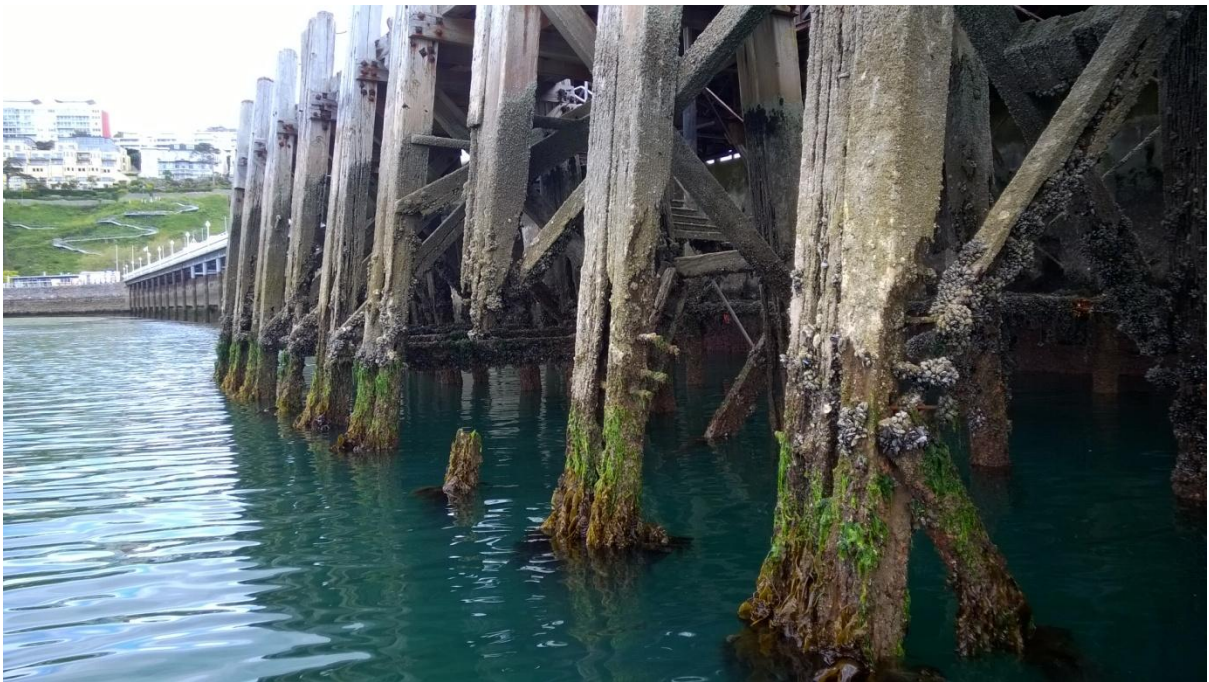
The timber landing adjacent to the widening displays complete or near-complete loss of section to several of its leg elements (see photo 9). Its stability in the marine environment is severely compromised with only residual strength and support in the remaining timber.

9 Timber landing with significant reduction and complete loss of material to key supporting members

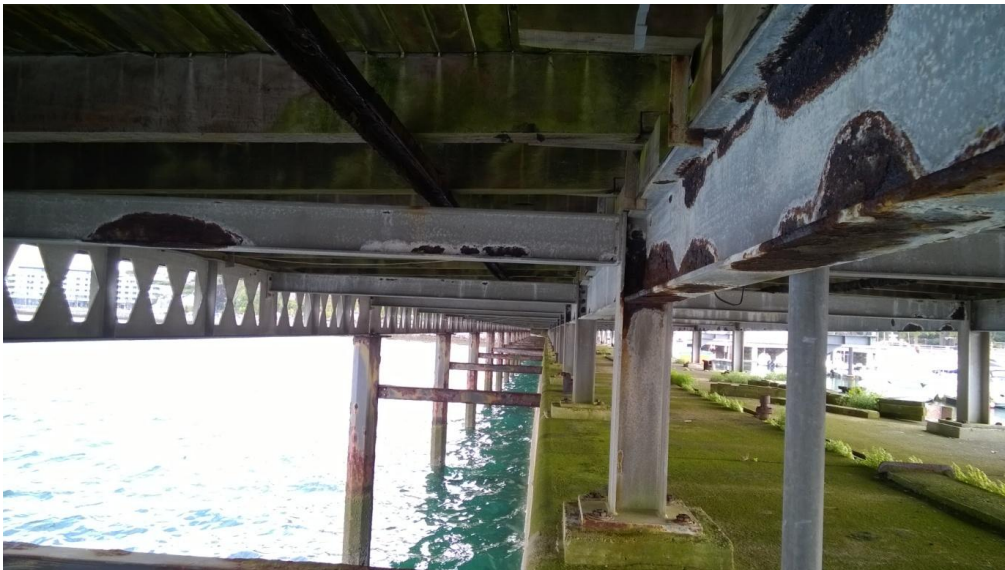
Timber deck replacement to the length of pier from the theatre to the boardwalk widening, works spanning several years, was completed with a final 450m² in 2015/16. At the same time as this final phase the supporting galvanised steel frame was treated with a high performance protective coating system. The remaining 1200m² of 1970s galvanised framing remains untreated and shows loss of protective zinc plating appearing as localised areas of corrosion now susceptible to the marine environment.

10 *View of failing galvanised protection to steel frame below boardwalk between theatre promenade and widening*

The galvanised steel frame supporting the boardwalk between the promenade at Princess Theatre and the widening has deteriorated to a condition requiring treatment recommended to be passive cathodic protection below the water line, and a high performance protective coating above.

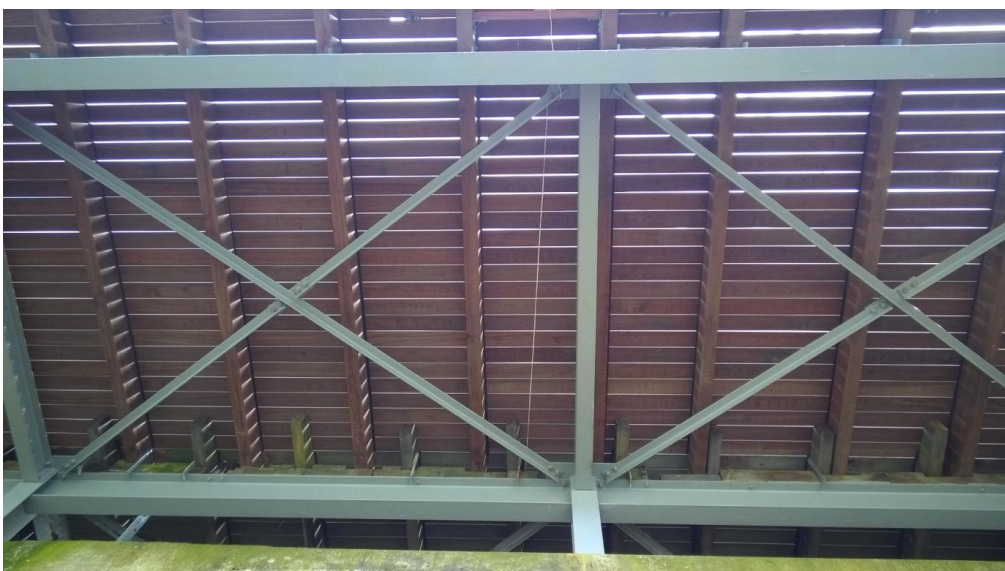
11 *View under boardwalk showing recent timber decking installation over 1970s-installed galvanised frame refurbished with protective coating*
