12th August 2020

Noise Impact Report/Assessment

Quay Club, Victoria Parade, Torquay TQ1 2BD

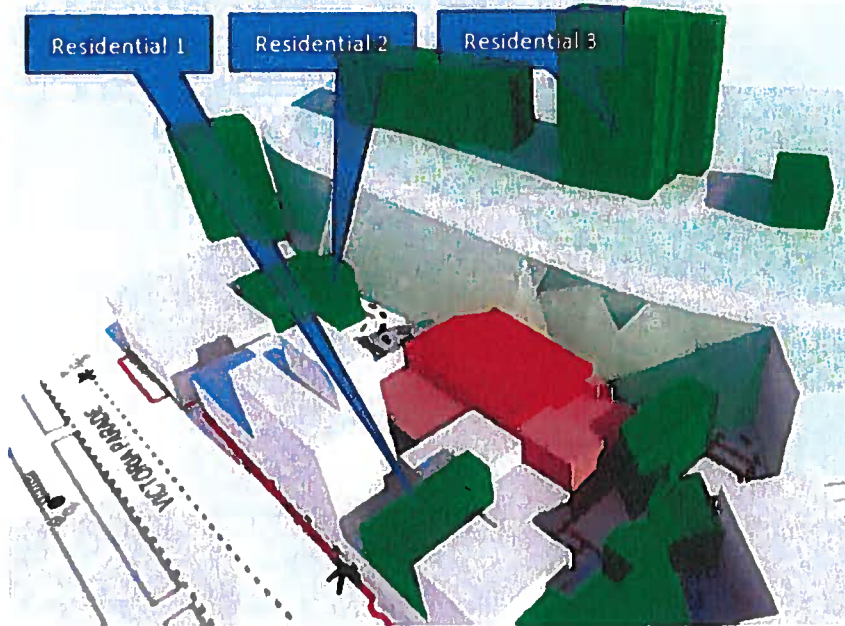
Residential Dwellings/Possible Noise Complaints

Traditionally there were two main complainants. Firstly the flats above Seamus O Donald (marked Residential 1) on Victoria Parade. The larger flat shares a party wall with the second room in the club. This was found an issue when the club was running as one large room. Now this area has been separated and is being treated as a second/chill out room with greatly reduced background levels.

The large block of residential flats (marked Residential 3) situated off Parkhill Road behind the club have previously complained about various issues regarding the premises. The complaints were mainly about customers in the smoking area as well as minor music levels emitting from defined areas.

The third possible complainant is the new apartments built to the rear of Victoria Parade (marked Residential 2) behind what is Cavern on the Quay. This is a slightly unknown area as they have been built after the club changed use to a gym so no night time running has been experienced. I would expect, because of their position, the ambient level to be higher than the levels around the club. This doesn't mean there will not be an issue but our current figures show very low breakout to this direction.

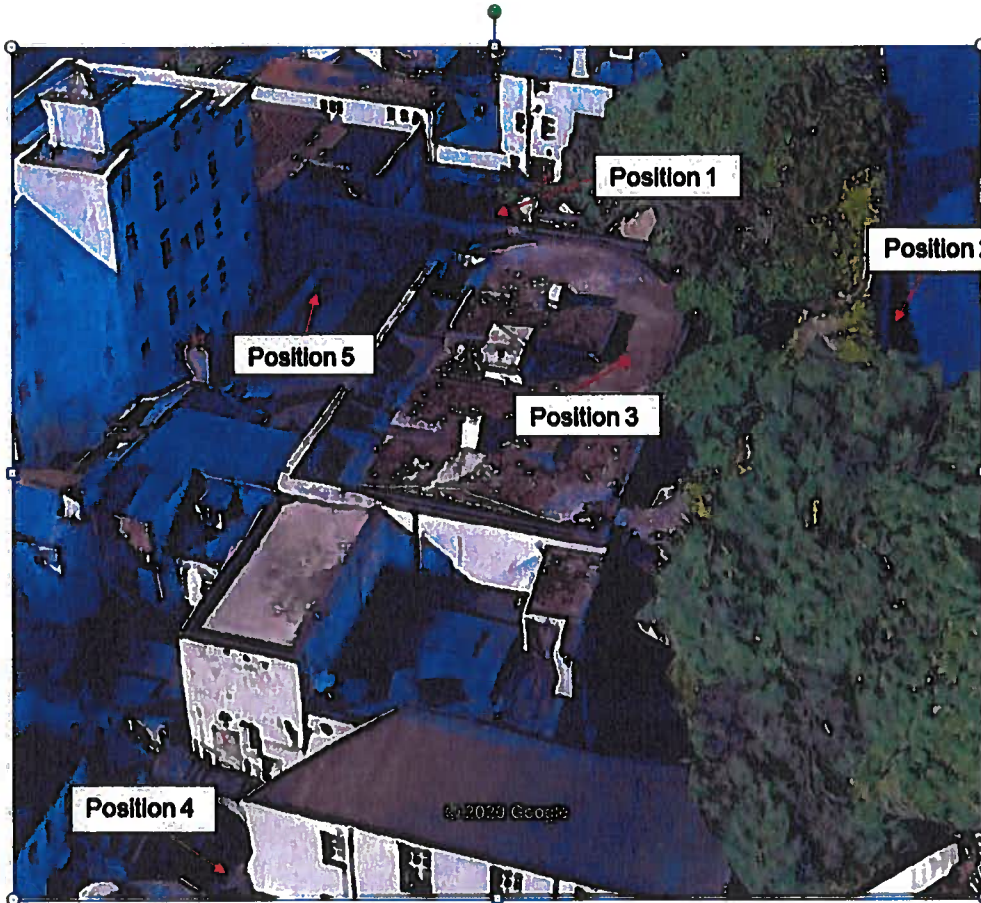
We ran four three-minute tests to ascertain the initial effectiveness of sound insulation and protection. The system was run to 110db centre of the dancefloor and readings then taken from various locations for measurement comparisons.

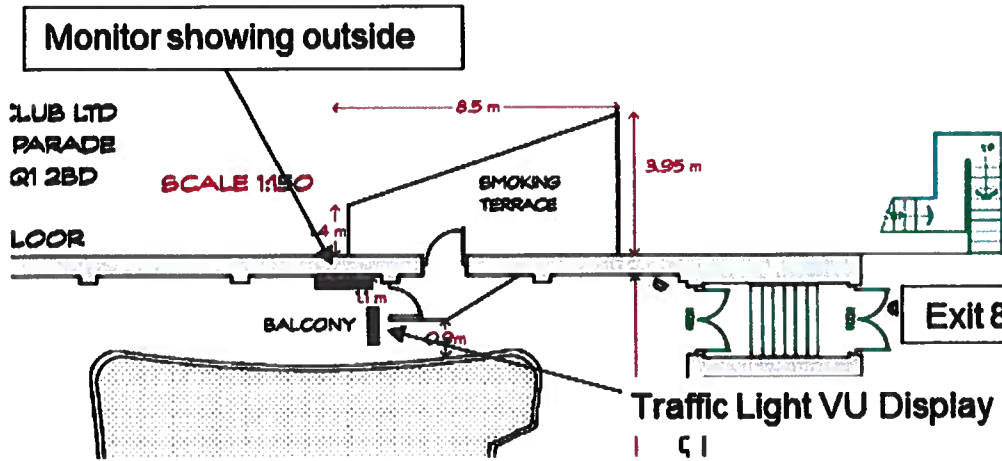
The original smoking terrace has now been decommissioned and a new area built as displayed on the updated plans on the first floor balcony level.

The terrace has a two door lobby system which will be monitored by a member of staff as directed by the noise management plan. The operative for this area will have a dedicated camera supplying real time images from outside on a monitor above the terrace doorway. They will also have a noise monitoring system installed with a traffic light VU display showing internally and externally.

This system will monitor levels on the terrace via a dedicated microphone and display levels as agreed with EHO. If the levels increase into the amber section then staff will have a visual display to warn customers of the problem and reduce the noise back to green. If the levels increase to the high red levels then the area will be closed for a time frame as agreed in the noise management plan.

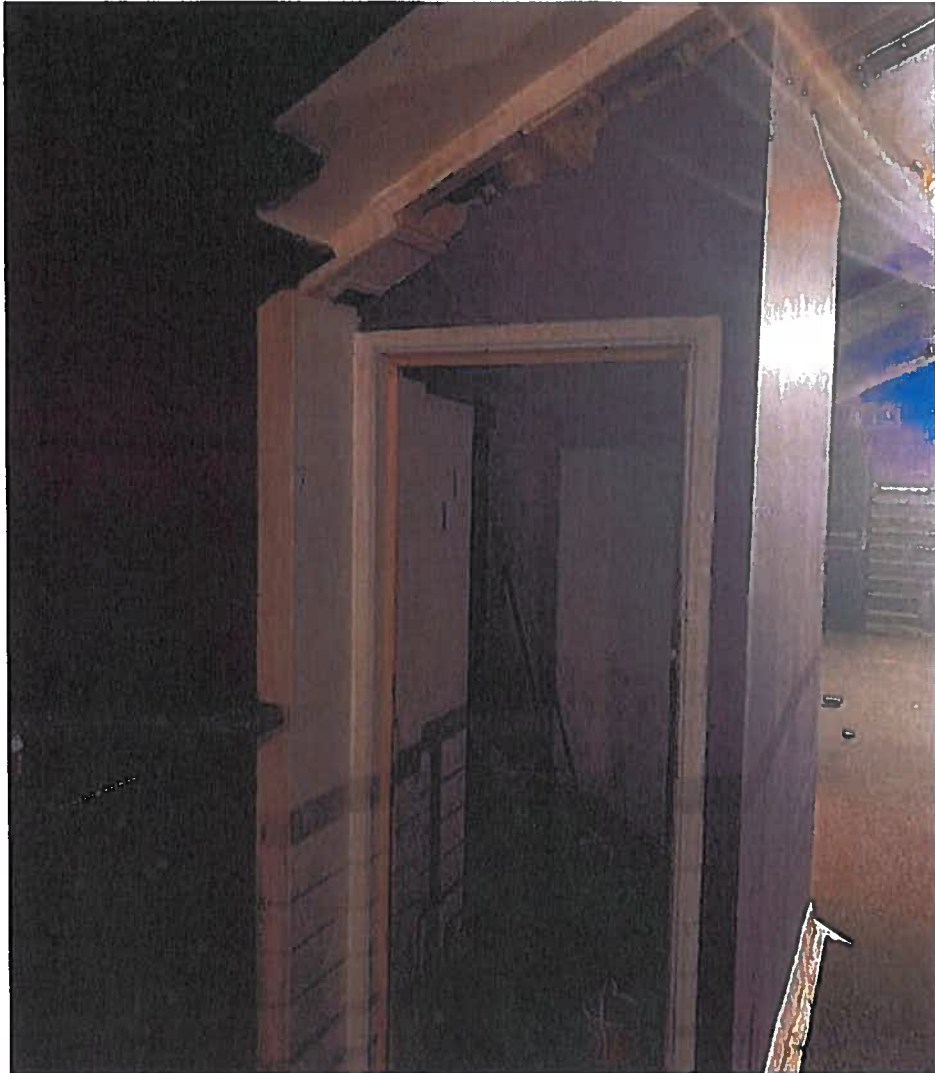
Main Toilets

The ground floor main toilets have shown high noise leakage. Originally this was thought to be the result of a single flat roof structure. After investigation this has now been found to be a false reading. The rear of all the toilet cubicles have windows that were opened with vents running into the club. These windows have now been blocked off and the vents removed. This is why it is so important to re-introduce the fresh intake system.

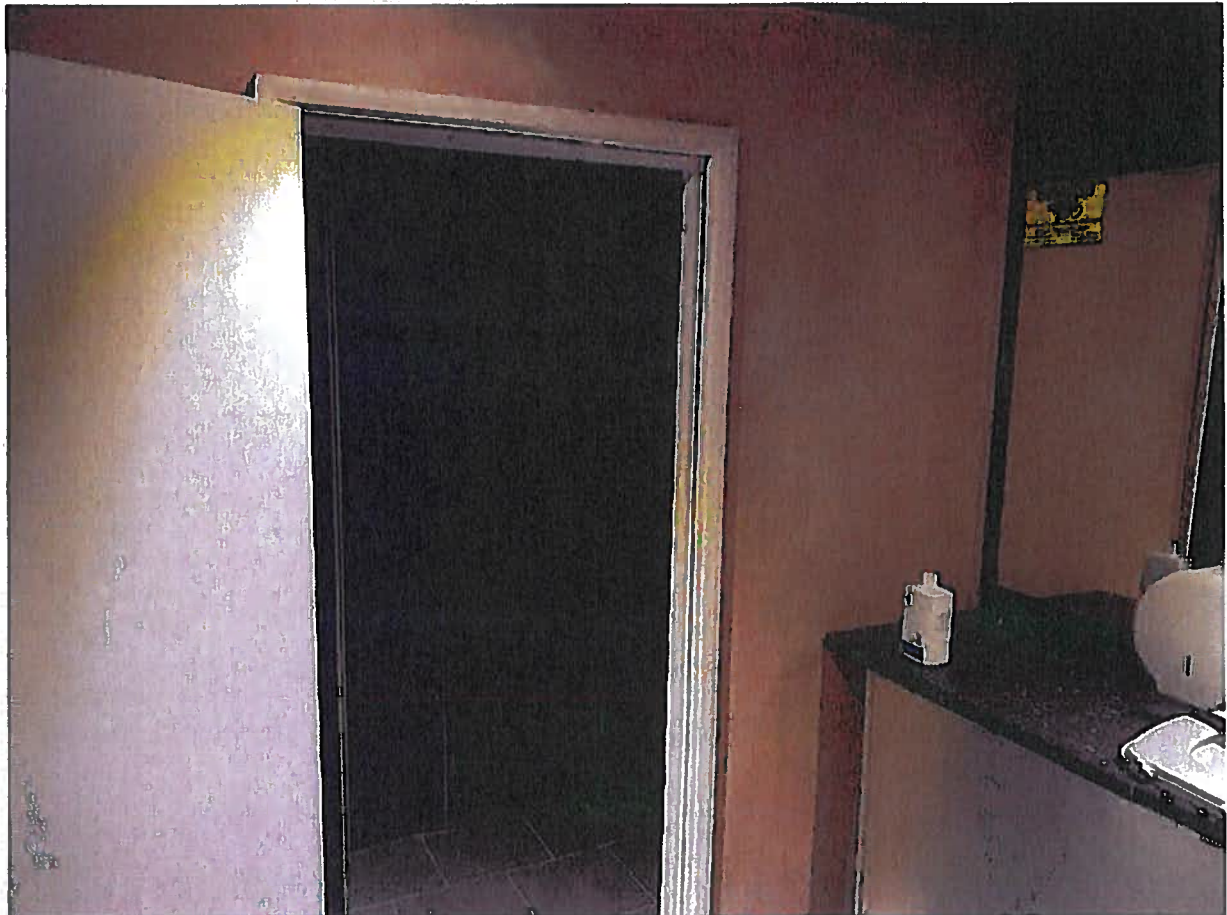
There is now a third lobby for both toilet blocks with all doors on closers which will reduce the level of noise entering the toilets.

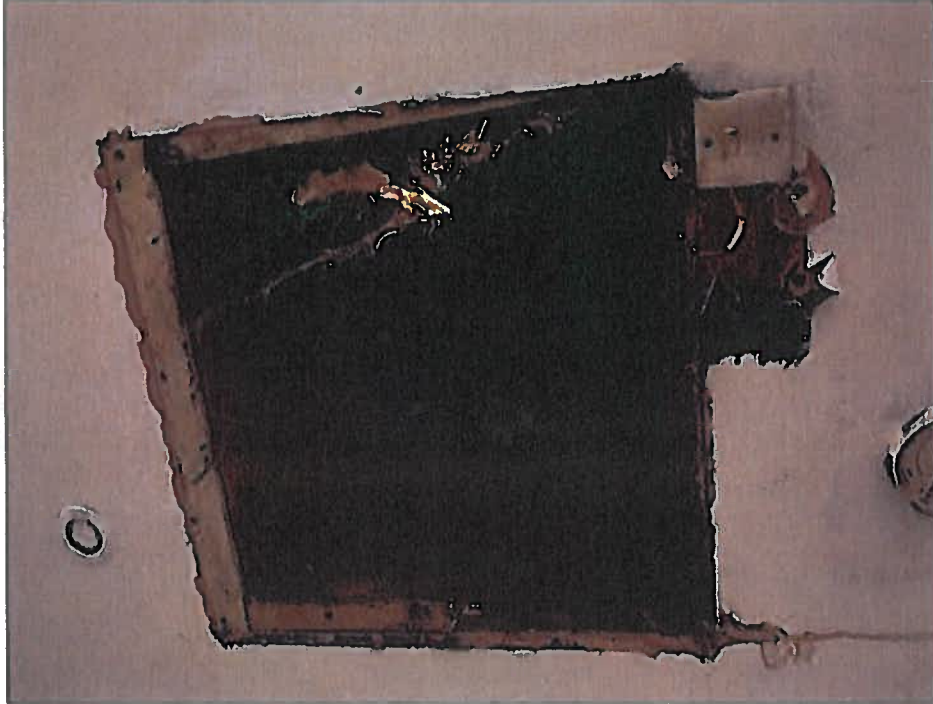
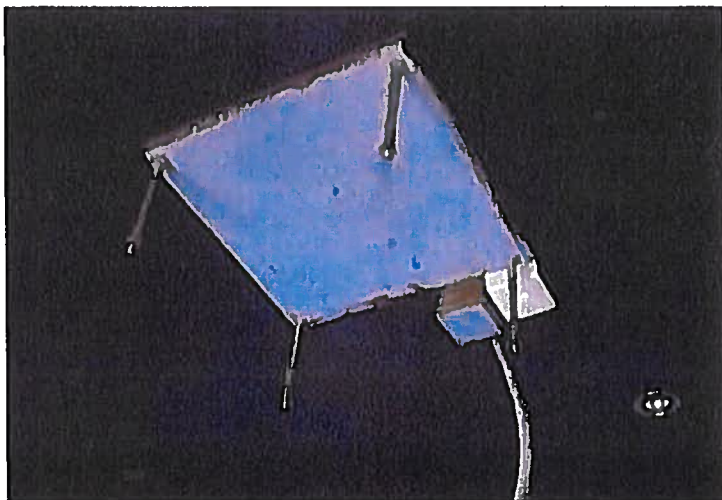
Existing Stair Well Fans

There were two existing fans mounted in the stairwells leading to the first floor balcony. These extracted straight out onto the roof via covers and were found to be a high leakage area. They have now been removed and will be filled in removing any noise emitting from them.

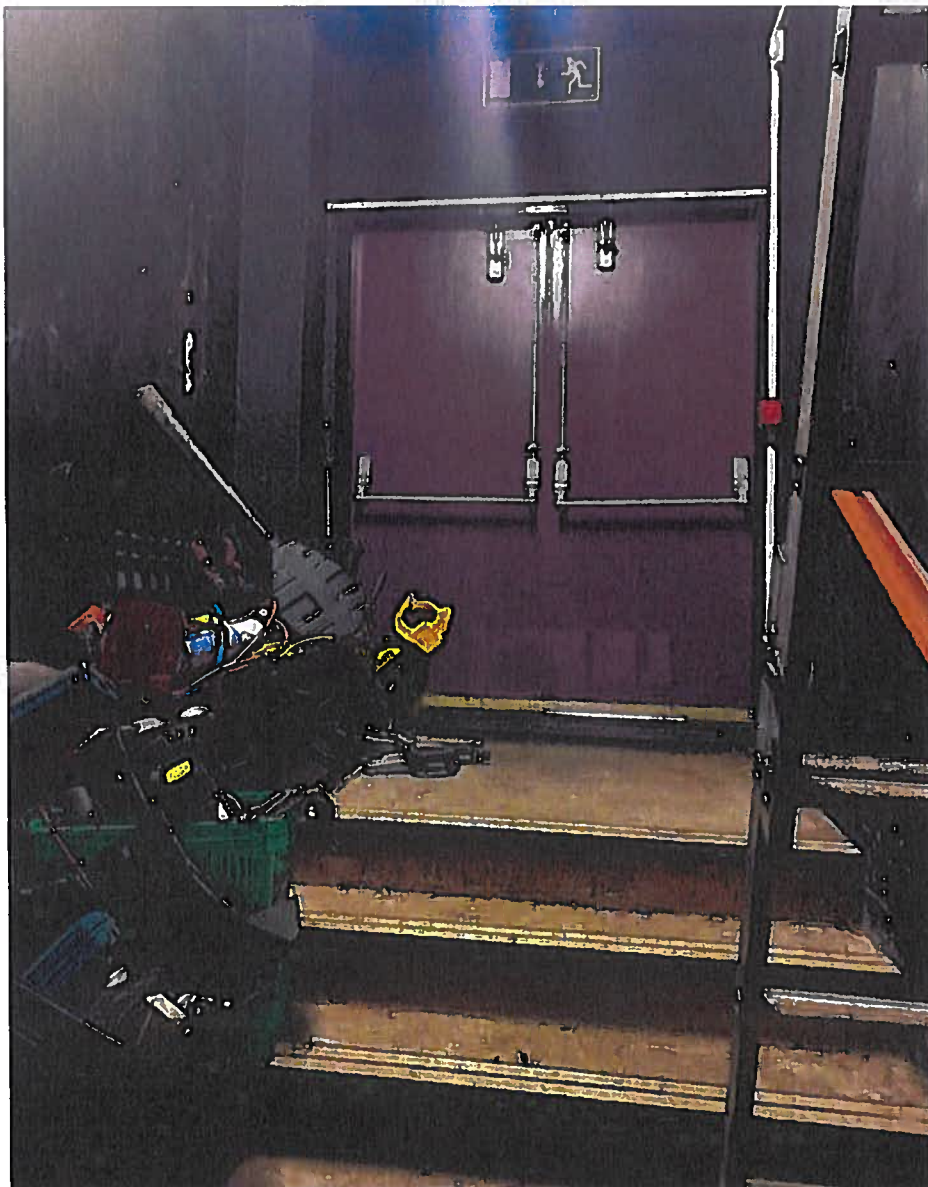
Fire Exit 8

This exit leads onto the roof area from the balcony. Most of the sound energy is directed away from here but there have been issues with noise emitting into this exit from the roof void via an entrance hatch. This hatch will now be fitted with a lock system and re-lined with a double acoustic door.

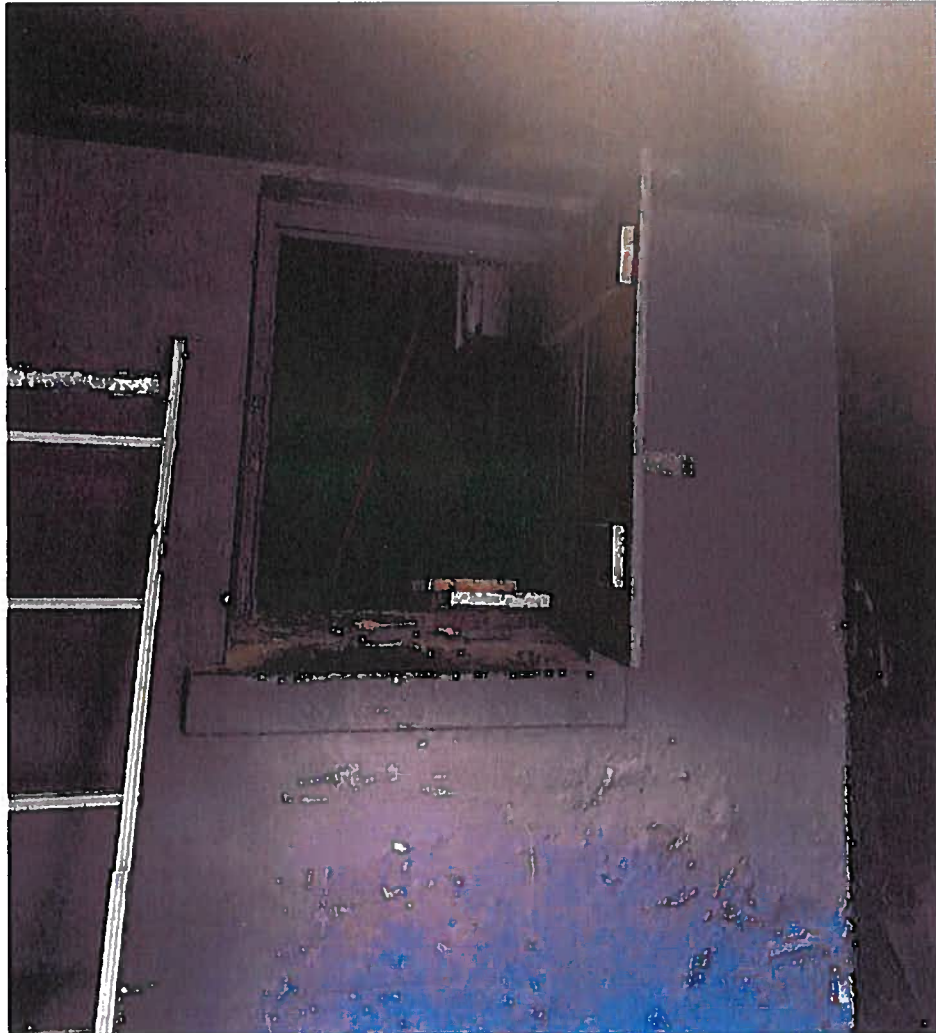
Fire Exit 9

This has been occasionally problematic but now it overlooks the new apartments to the rear of Cavern on the Quay it might prove a larger issue. We have suggested a second door/lobby on the top of the exit to stop any potential issues and deflect the sound upwards and out of line of sight to the new apartments. The door will also be fitted with a magnetic lock system connected to the fire alarm panel. This will only open/release in an emergency and will stop unwanted exits etc.
