Condition Survey

P0697AB - Parkfield House

38
Esplanade Road
Paignton
Devon

DATE: 13/04/2022

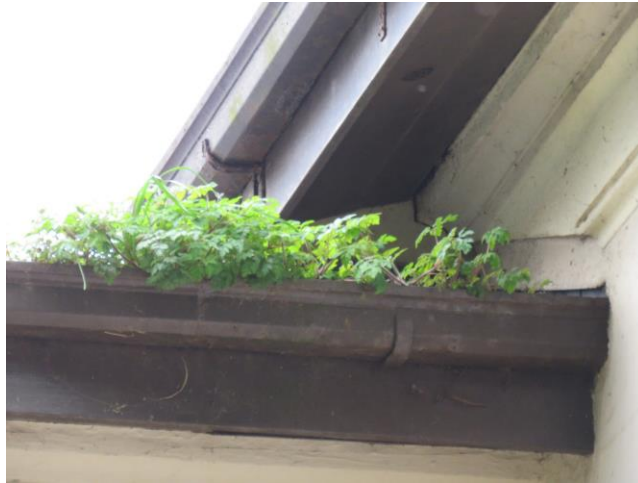
Identified Work	Floor	Room No	Defect Location	Description	Condition	Repair	P1	P2	P3	P4
IW00052746			Remove and clear/flush clear.	Painted cast-iron and plastic gutters and downpipes - notable amounts of vegetation in gutters.	C				2,000

Painted cast-iron and plastic gutters and downpipes - notable amounts of vegetation in gutters.

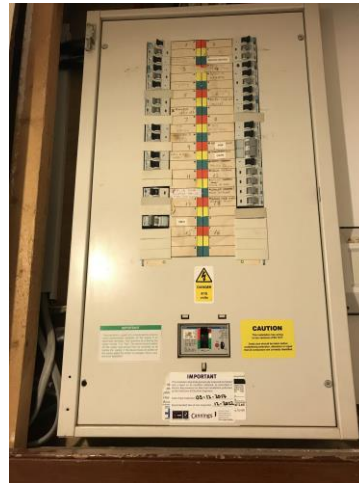
IW00052768

36 Way Hagar TPN D Board on ground floor, 14 Way Hagar SPN in 1st floor Cupboard, 6 Way SPN Legrand in Laundry

Cover missing from Hagar 16W TPN, install replacement

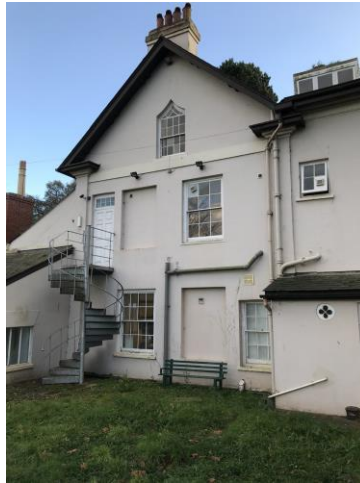
IW00052773

High level T halogen floods

Replace with new LED flood lights

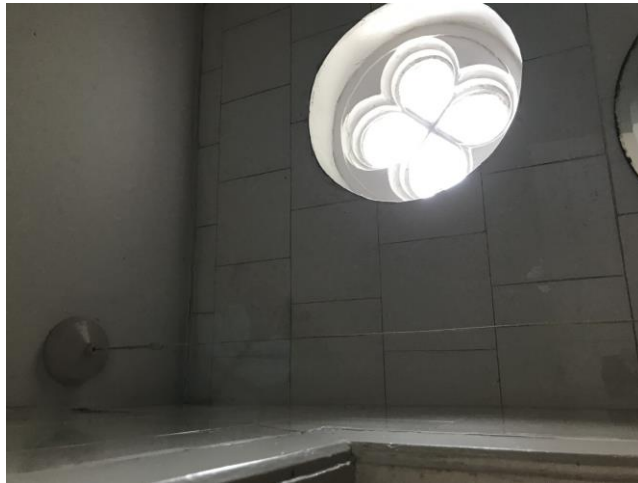
IW00052788

Ground floor WC - Damaged pull switch

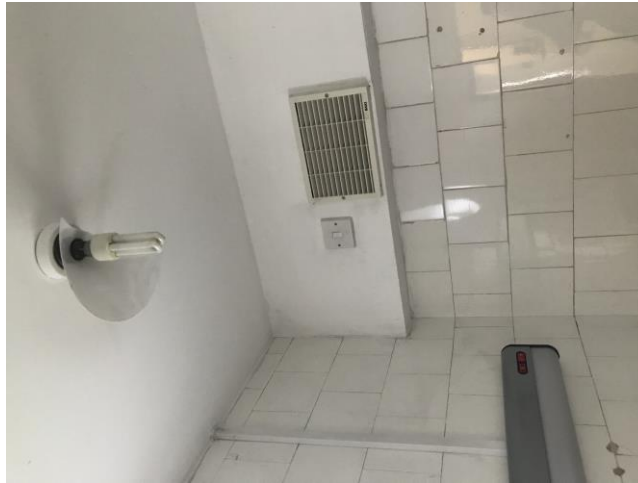
IW00052789

Ground & 1st floor - WC Light broken, Bathroom light not HO batten holder

Replace old batten holders with IP54 bulkheads fittings

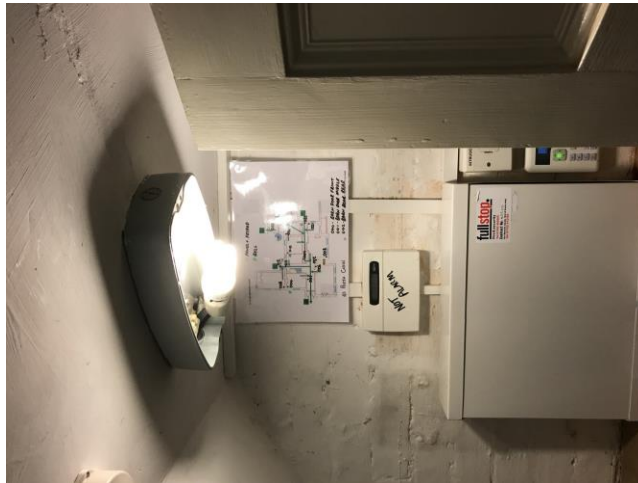
IW00052790

Ground floor Cupboard - Cover missing from light fitting

Replace with new IP54 bulkhead fitting

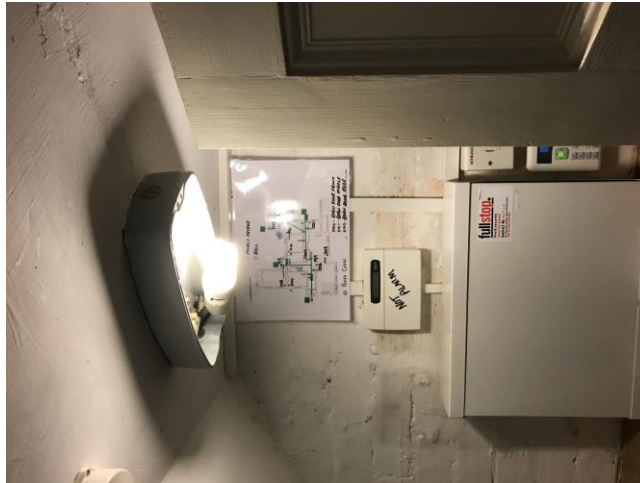
IW00052791

Ground floor Cupboard - Damaged light fitting

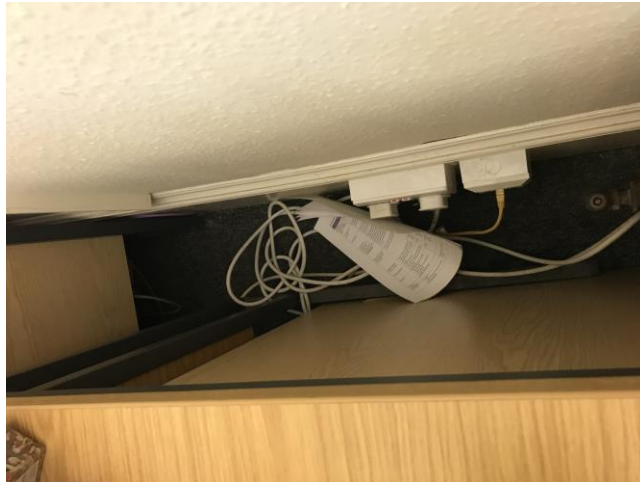
IW00052792

Reception office - Extension leads used under desks for IT equipment

Install additional sockets

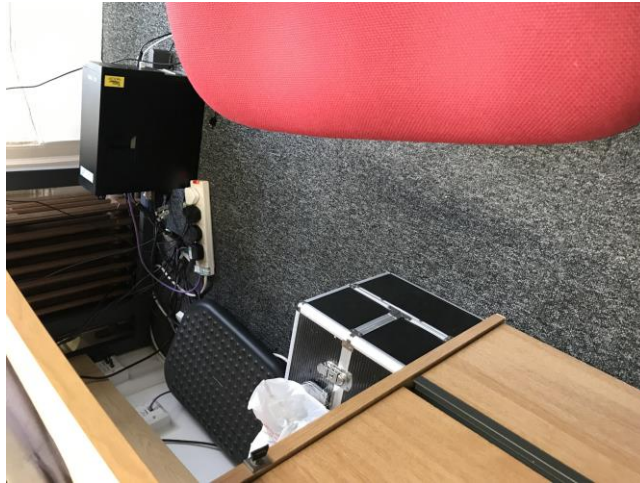
IW00052793

Room F4 - Extension leads used under desks for IT equipment

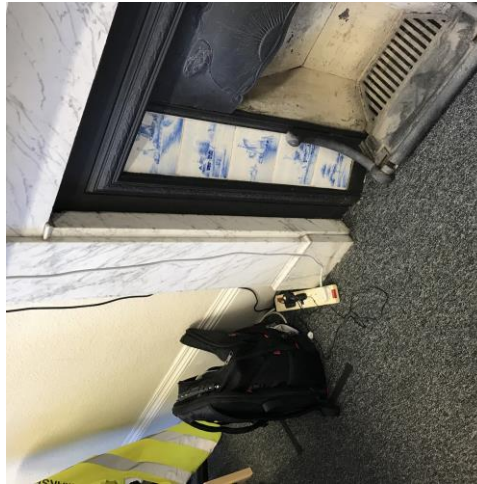
IW00052794

Room F5 - Extension leads used under desks for IT equipment

Install additional sockets

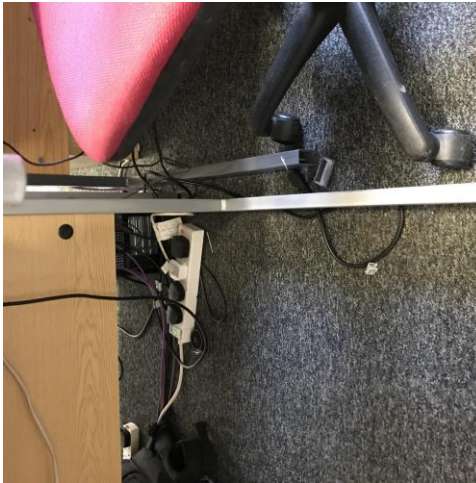
IW00052795

Room F2 - Extension leads used under desks for IT equipment

Install additional sockets

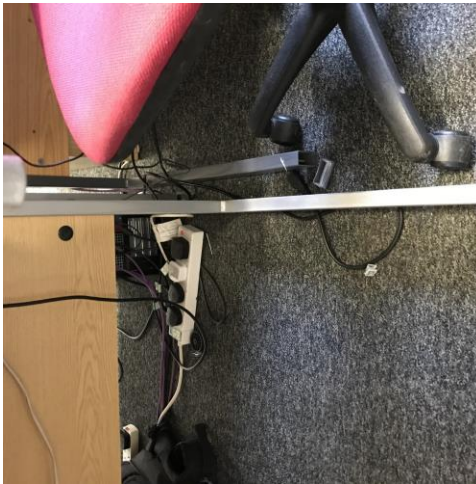
IW00052796

Room F3 - Extension leads used under desks for IT equipment

Install additional sockets

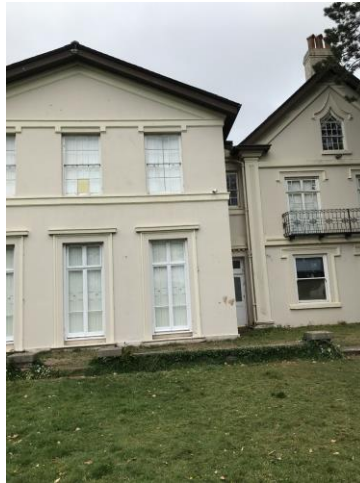
IW00052797

Wall mounted outside - High level Son & TH flood lights

Replace flood lights with LED equivalent

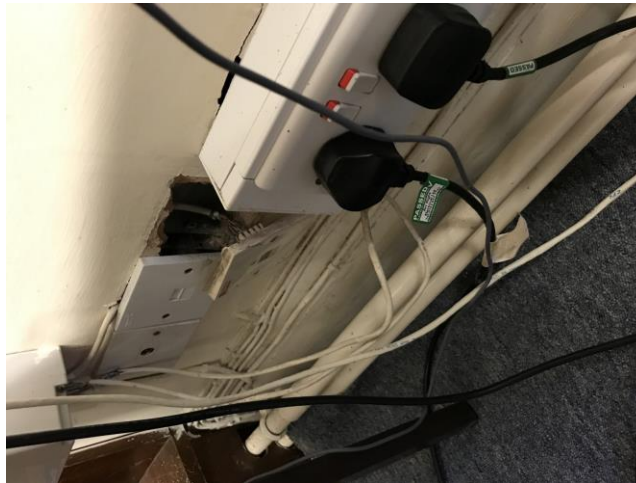
IW00052798

Panelled room - Telephone outlet plate loose

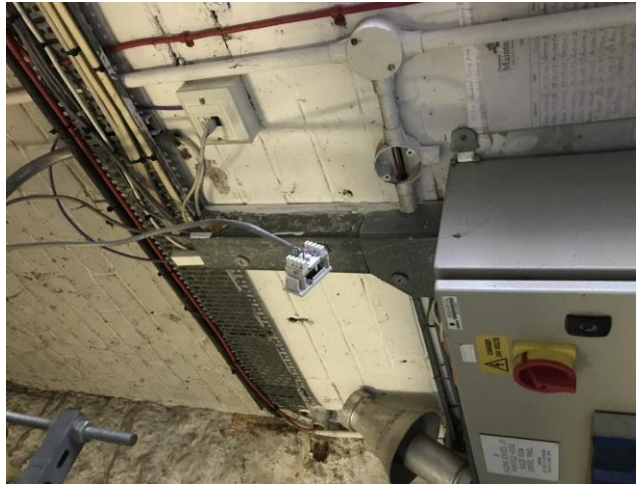
IW00052800

RJ45 outlet hanging loose with bare connections

Install surface single box and RJ45 mounting plate

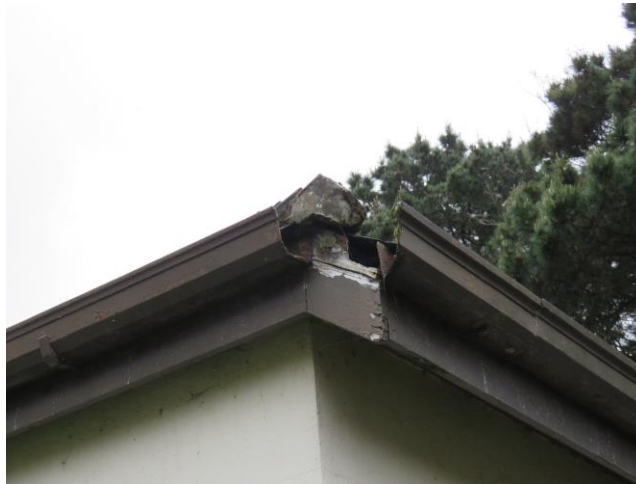
IW00054626

Painted timber fascias and soffits - generally satisfactory with localised areas of rotten timber - nominal sum applied to replace.

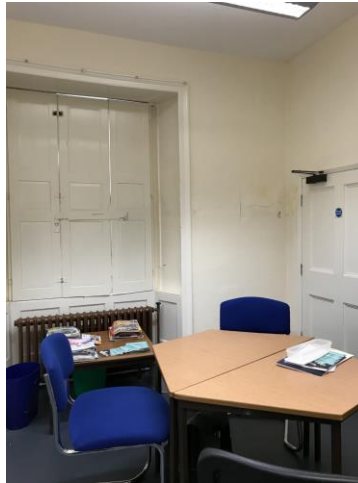
IW00054638			Localised areas of peeling paintwork and spalling plaster to be removed/hacked off and replaced with new to match existing. Maintain as part of a cyclical programme of internal redecoration. Nominal sum applied for localised repairs.	Combination of painted plastered random masonry and lathe and plaster partitions. Generally good to satisfactory with localised areas of plaster defects, presumably linked to historic incidents of water ingress.	B				0	
------------	--	--	---	---	---	--	--	--	---	--

Combination of painted plastered random masonry and lathe and plaster partitions. Generally good to satisfactory with localised areas of plaster defects, presumably linked to historic incidents of water ingress.
