# PRINCESS GARDENS FOUNTAIN TORQUAY

**Condition Report – January 2018**

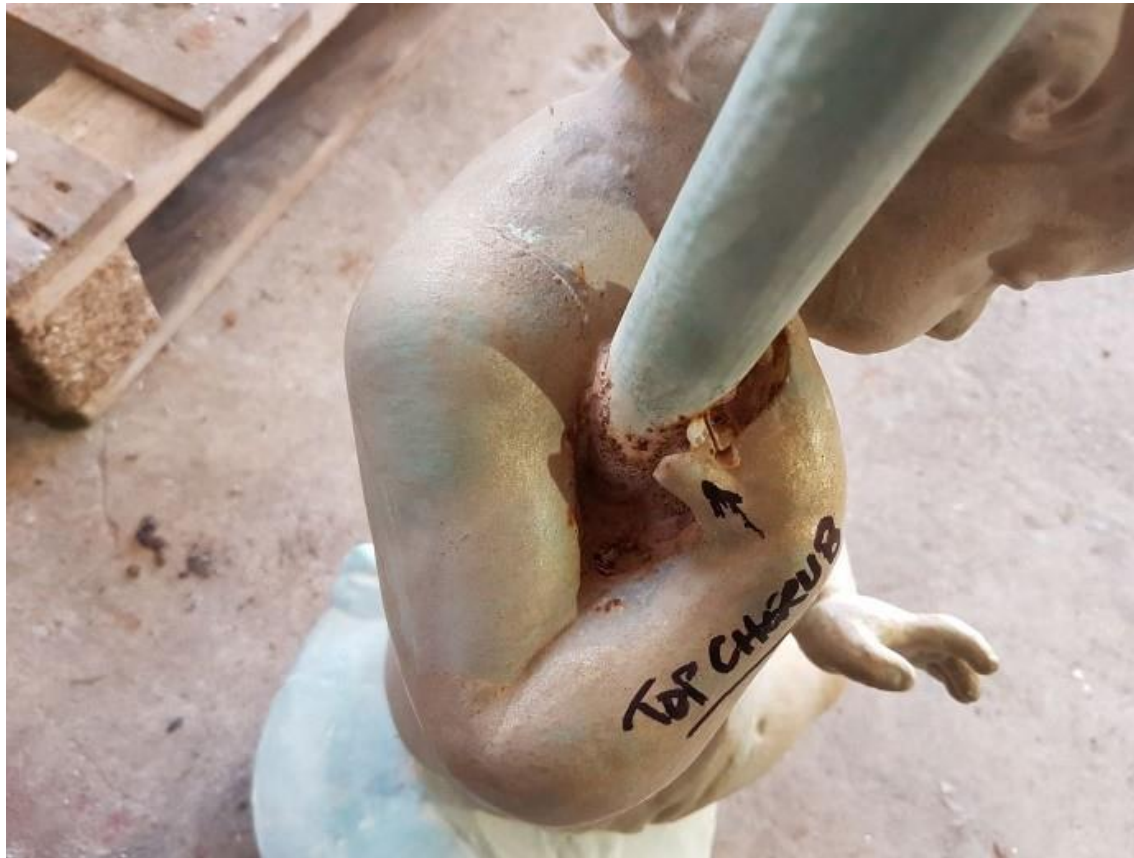
Level 2 - Second Bowl				
Bowl 2		Good	Cleaning & repainting only	See General Note 4. General Pitting
Pedestal 2		Good	Cleaning & repainting only	
Cherub & Upper Spray		Part of Thumb missing on flower stem. Flower stem is bent. Otherwise in good condition	Replace missing pieces and straighten out stem

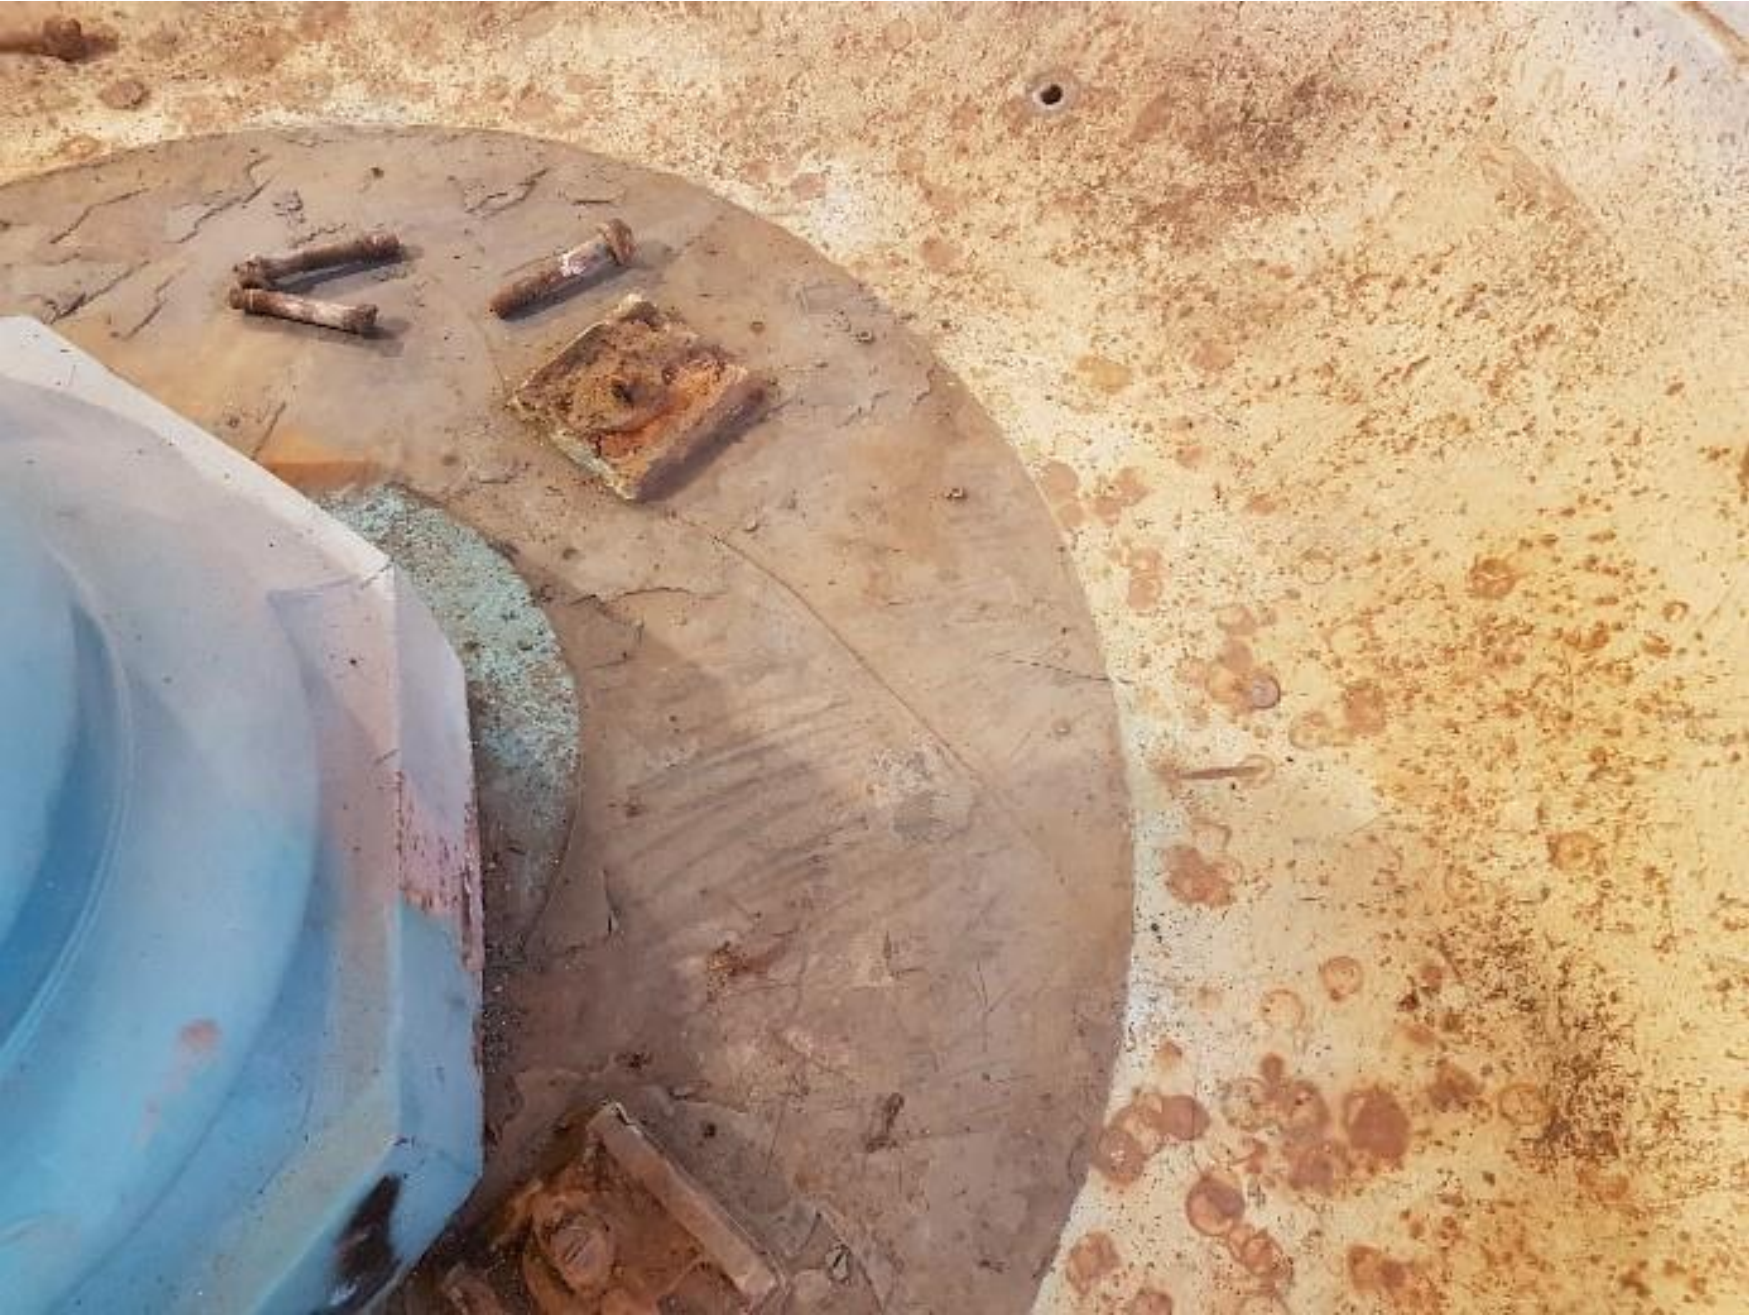
Bowl 1

Component Name	Component ID No.	Condition	Recommended Action	Comments
<b>Level 1 - First Bowl</b>				
<b>Bowl 1</b>		Crack on inside of bowl where cover plate is situated - about 800mm long, full penetration	Repair crack	
<b>Stay</b>	1	Good	Cleaning & repainting only	
<b>Stay</b>	2	Good	Cleaning & repainting only	
<b>Stay</b>	3	Good	Cleaning & repainting only	
<b>Stay</b>	4	Good	Cleaning & repainting only	
<b>Leaf Strip</b>	1	Joint Sleeve to be extended	Extension Piece Req'd	
<b>Leaf Strip</b>	2	Joint Sleeve to be extended	Extension Piece Req'd	
<b>Leaf Strip</b>	3	Good	Cleaning & repainting only	
<b>Leaf Strip</b>	4	Joint Sleeve to be extended	Extension Piece Req'd	
<b>Leaf Strip</b>	5	Joint Sleeve to be extended	Extension Piece Req'd	
<b>Leaf Strip</b>	6	Joint Sleeve to be extended	Extension Piece Req'd	
<b>Leaf Strip</b>	7	Joint Sleeve to be extended	Extension Piece Req'd	
<b>Leaf Strip</b>	8	Joint Sleeve to be extended	Extension Piece Req'd

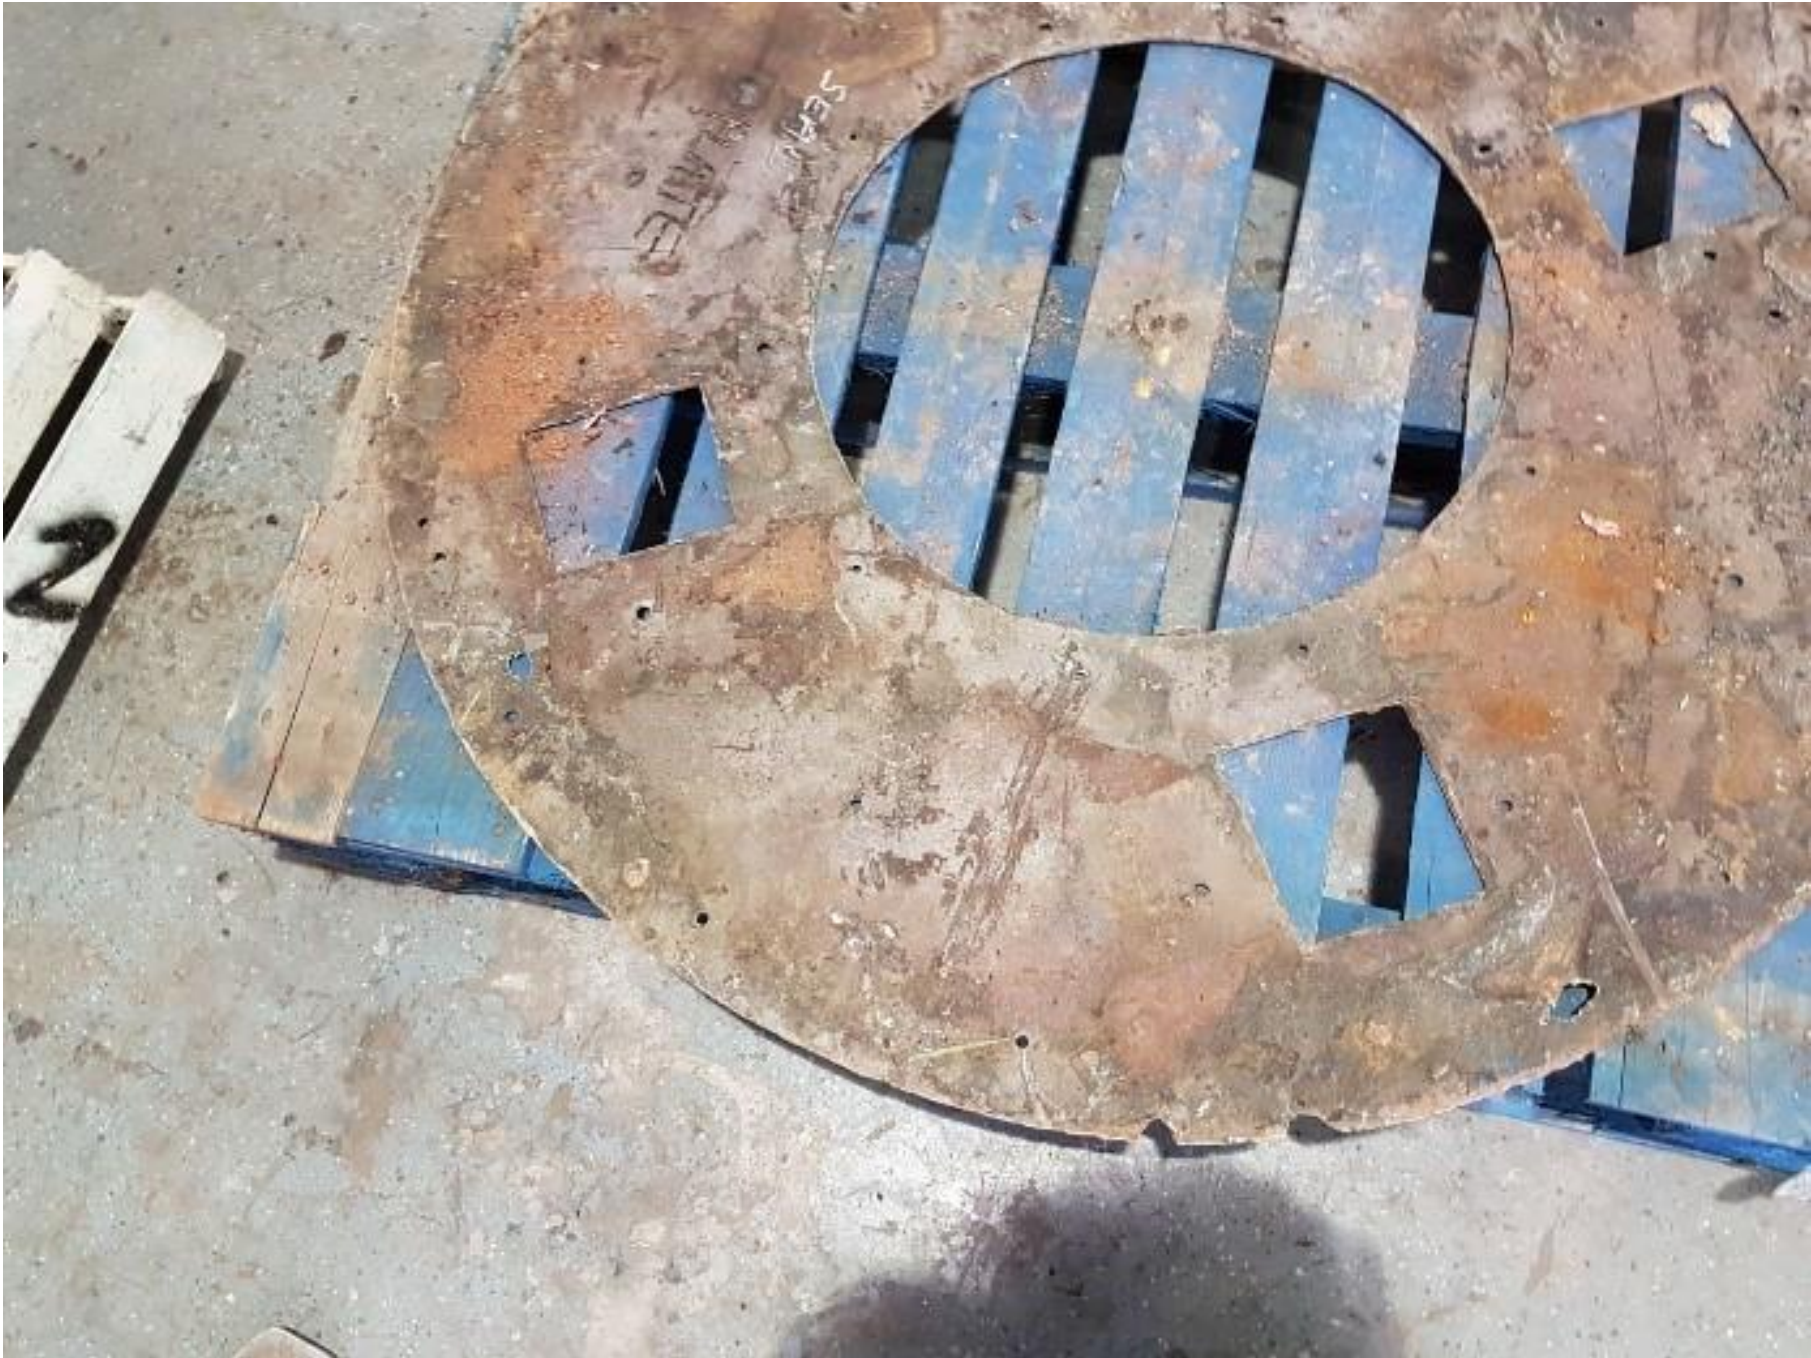
Internal Ring Plate

<b>Internal Repair Ring Plate</b>		Very thin in places and very corroded	Replace	
<b>Pedestal 1</b>				
<b>Upper Central Column</b>				Newton Forge recommend that the upper central pillar and pedestal remains intact because further disassembly may cause irreparable damage on an otherwise sound structure.
<b>Heron Leaf</b>	1	Good	Cleaning & repainting only	
<b>Heron Leaf</b>	2	Good	Cleaning & repainting only	
<b>Heron Leaf</b>	3	Good	Cleaning & repainting only	
<b>Heron Leaf</b>	4	Good	Cleaning & repainting only	
<b>Heron</b>	1	Threaded stud on base is corroded	Repair stud	
<b>Heron</b>	2	Threaded stud on base is corroded	Repair stud

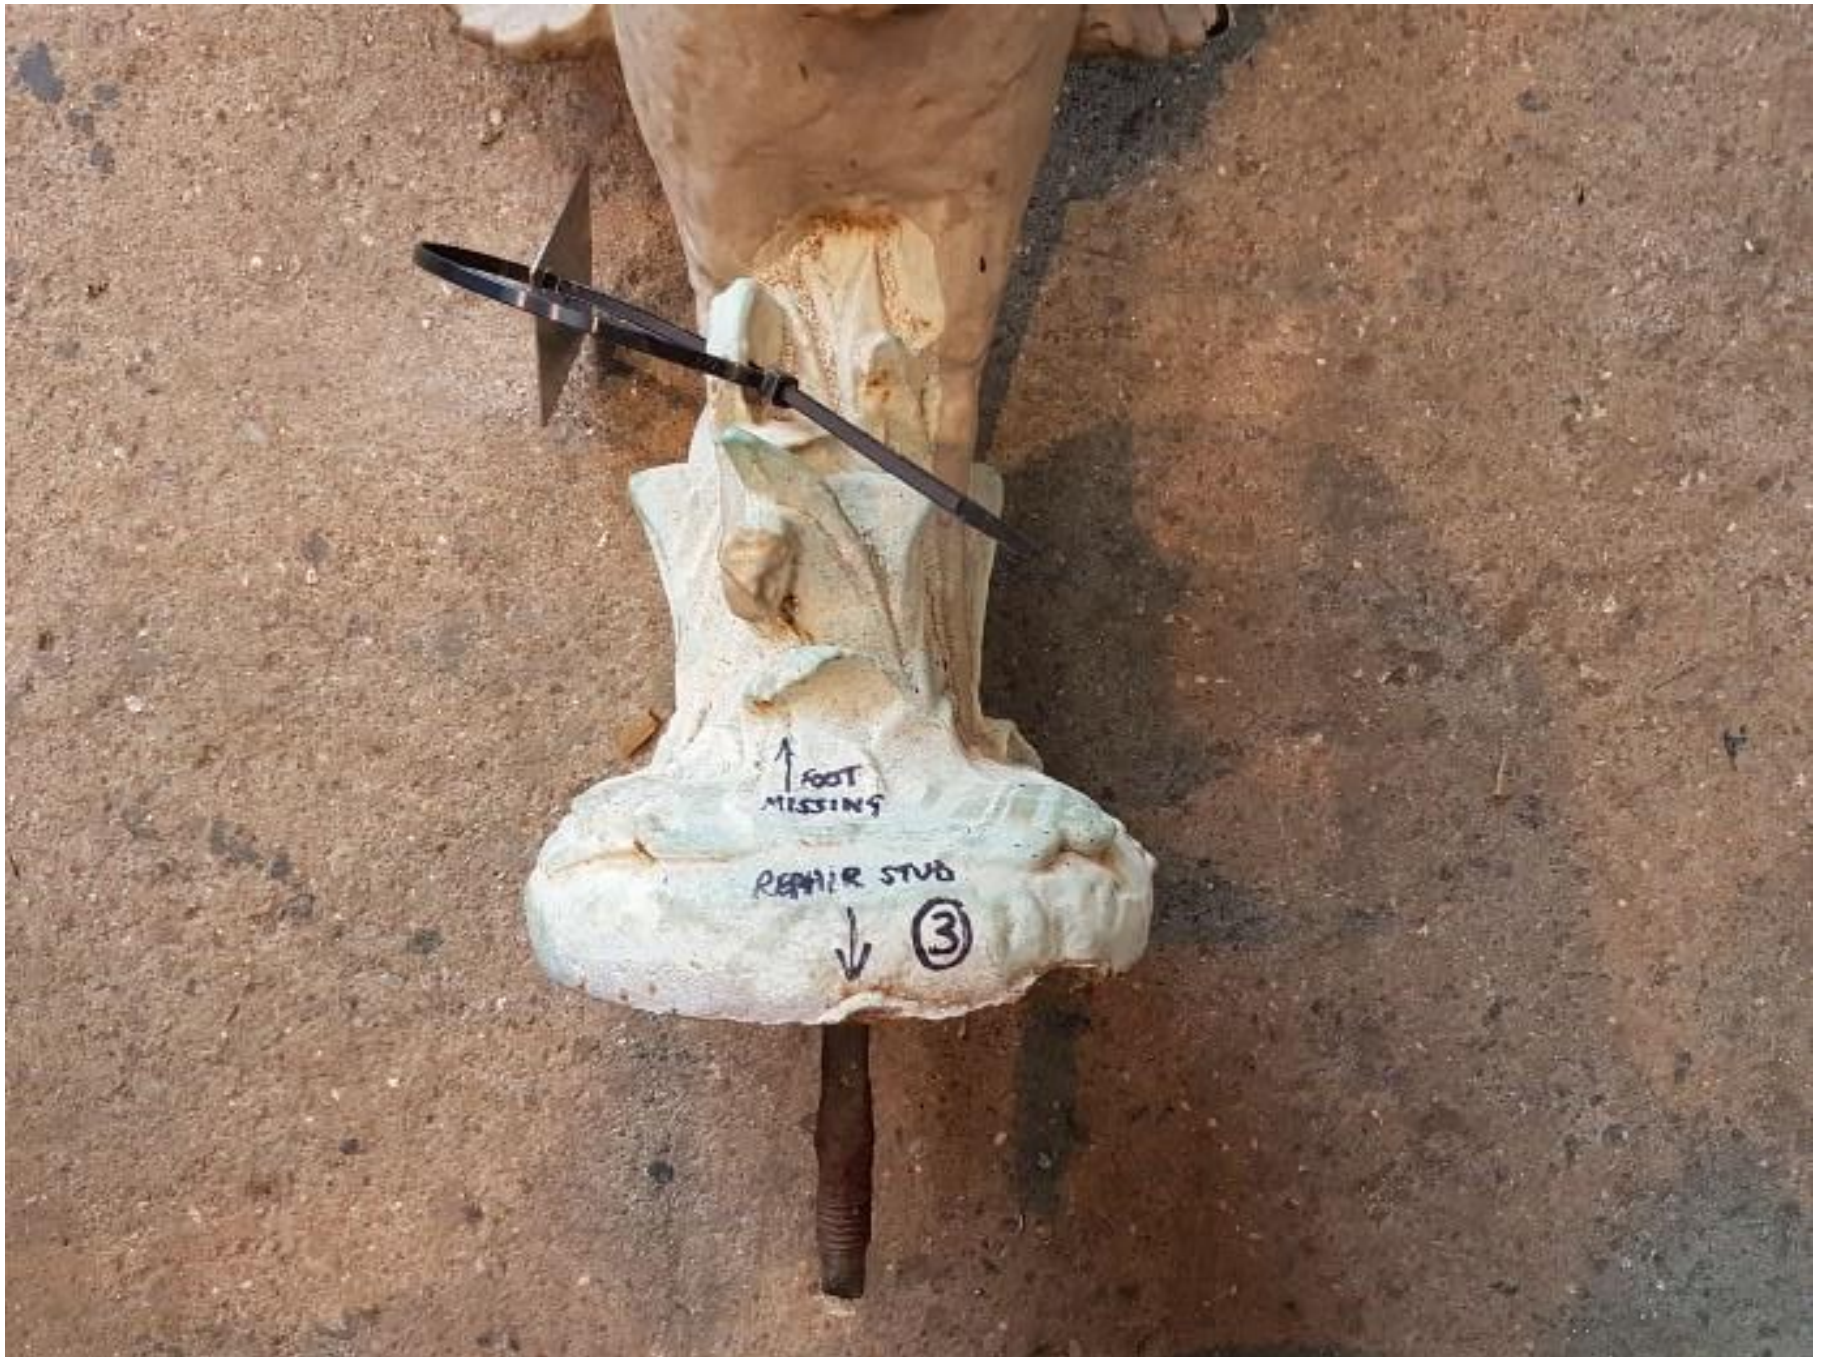
Heron No.3

Component Name	Component ID No.	Condition	Recommended Action	Comments
Heron	3	Foot missing	Replace Crane's Foot	
Heron	3	Threaded stud on base is corroded.	Repair stud	
Heron	4	Threaded stud on base is corroded	Repair stud	
Daffodil	1.5	Stem Broken	Repair Stem	
Daffodil	2.5	Intact but thinning at bolt holes	Repair Stem	
Daffodil	3.5	Stem Broken	Repair Stem	
Daffodil	4.5	Intact but thinning at bolt holes	Repair Stem	
Daffodil	5.5	Intact but thinning at bolt holes	Repair Stem	
Daffodil	6.5	Stem Broken	Repair Stem	
Daffodil	7.5	Stem Broken	Repair Stem	
Daffodil	8.5	Stem Broken	Repair Stem	
Daffodil Leaf	1	Good	Cleaning & repainting only	
Daffodil Leaf	2	Good	Cleaning & repainting only	
Daffodil Leaf	3	Good	Cleaning & repainting only	
Daffodil Leaf	4	Good	Cleaning & repainting only	
Daffodil Leaf	5	Good	Cleaning & repainting only	
Daffodil Leaf	6	Good	Cleaning & repainting only	
Daffodil Leaf	7	Good	Cleaning & repainting only

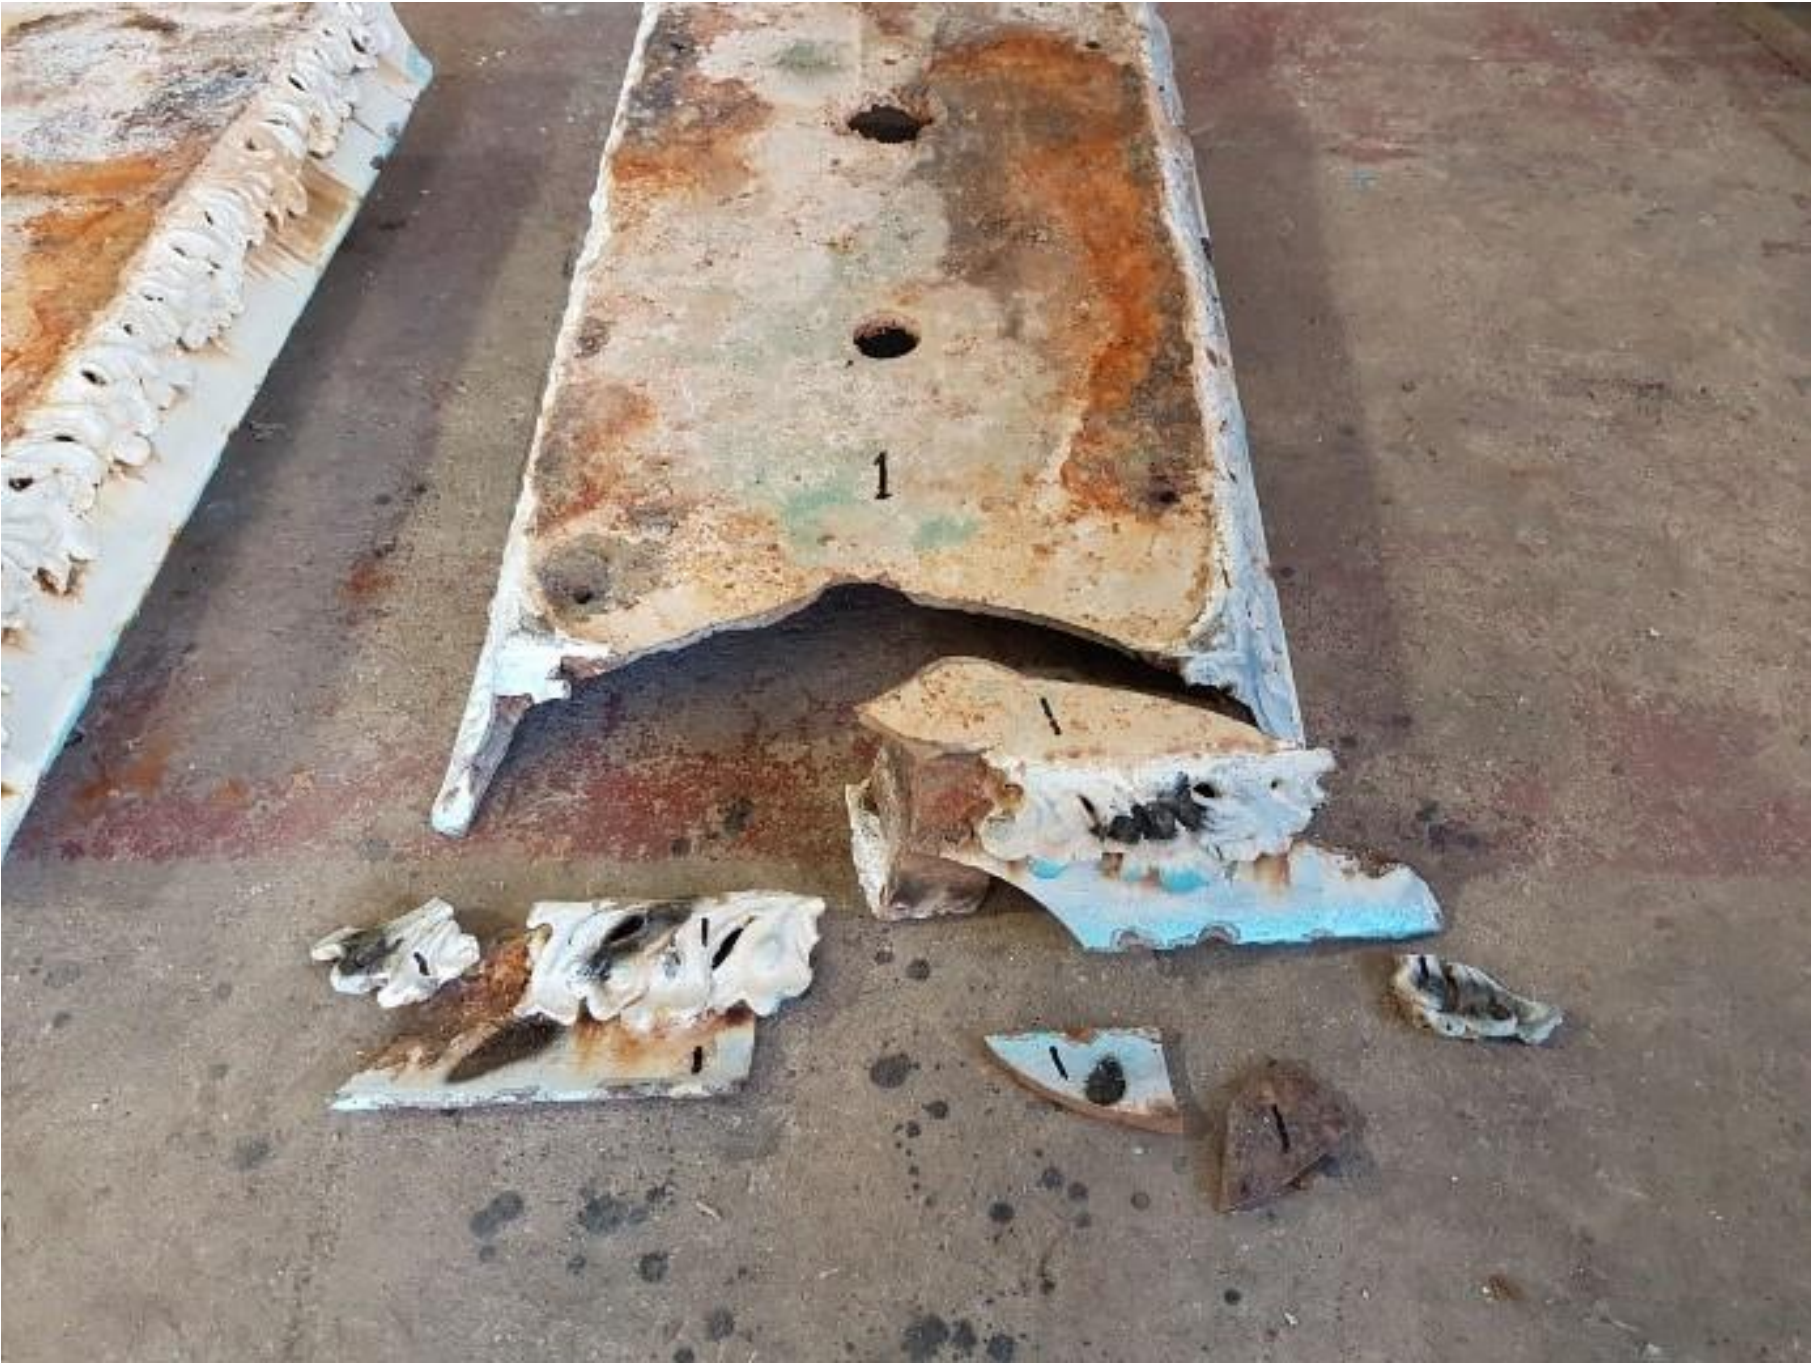
Decorative Plinth No.1

Component Name	Component ID No.	Condition	Recommended Action	Comments
<b>Lower Fountain at Ground Level</b>				
Decorative Plinth	1	Decoration is broken into multiple pieces, small pieces missing	Replace broken decoration	Although there is possibly further corrosion on the plinths under the decorative castings, Newton Forge recommend that they are left in tact because further disassembly may cause irreparable damage to an otherwise sound structure
Decorative Plinth	1	Plinth is broken into several pieces along front edge	Repair broken plinth	
Decorative Plinth	2	Good	Cleaning & repainting only	
Decorative Plinth	3	Plinth is broken along back side	Repair plinth	Slight wear of location point for Koi Carp 3 but this should not prevent reinstatement
Decorative Plinth	3	Decoration is broken on one side of plinth	Repair decoration	
Decorative Plinth	3	Small piece missing from opposite side	Build up missing piece

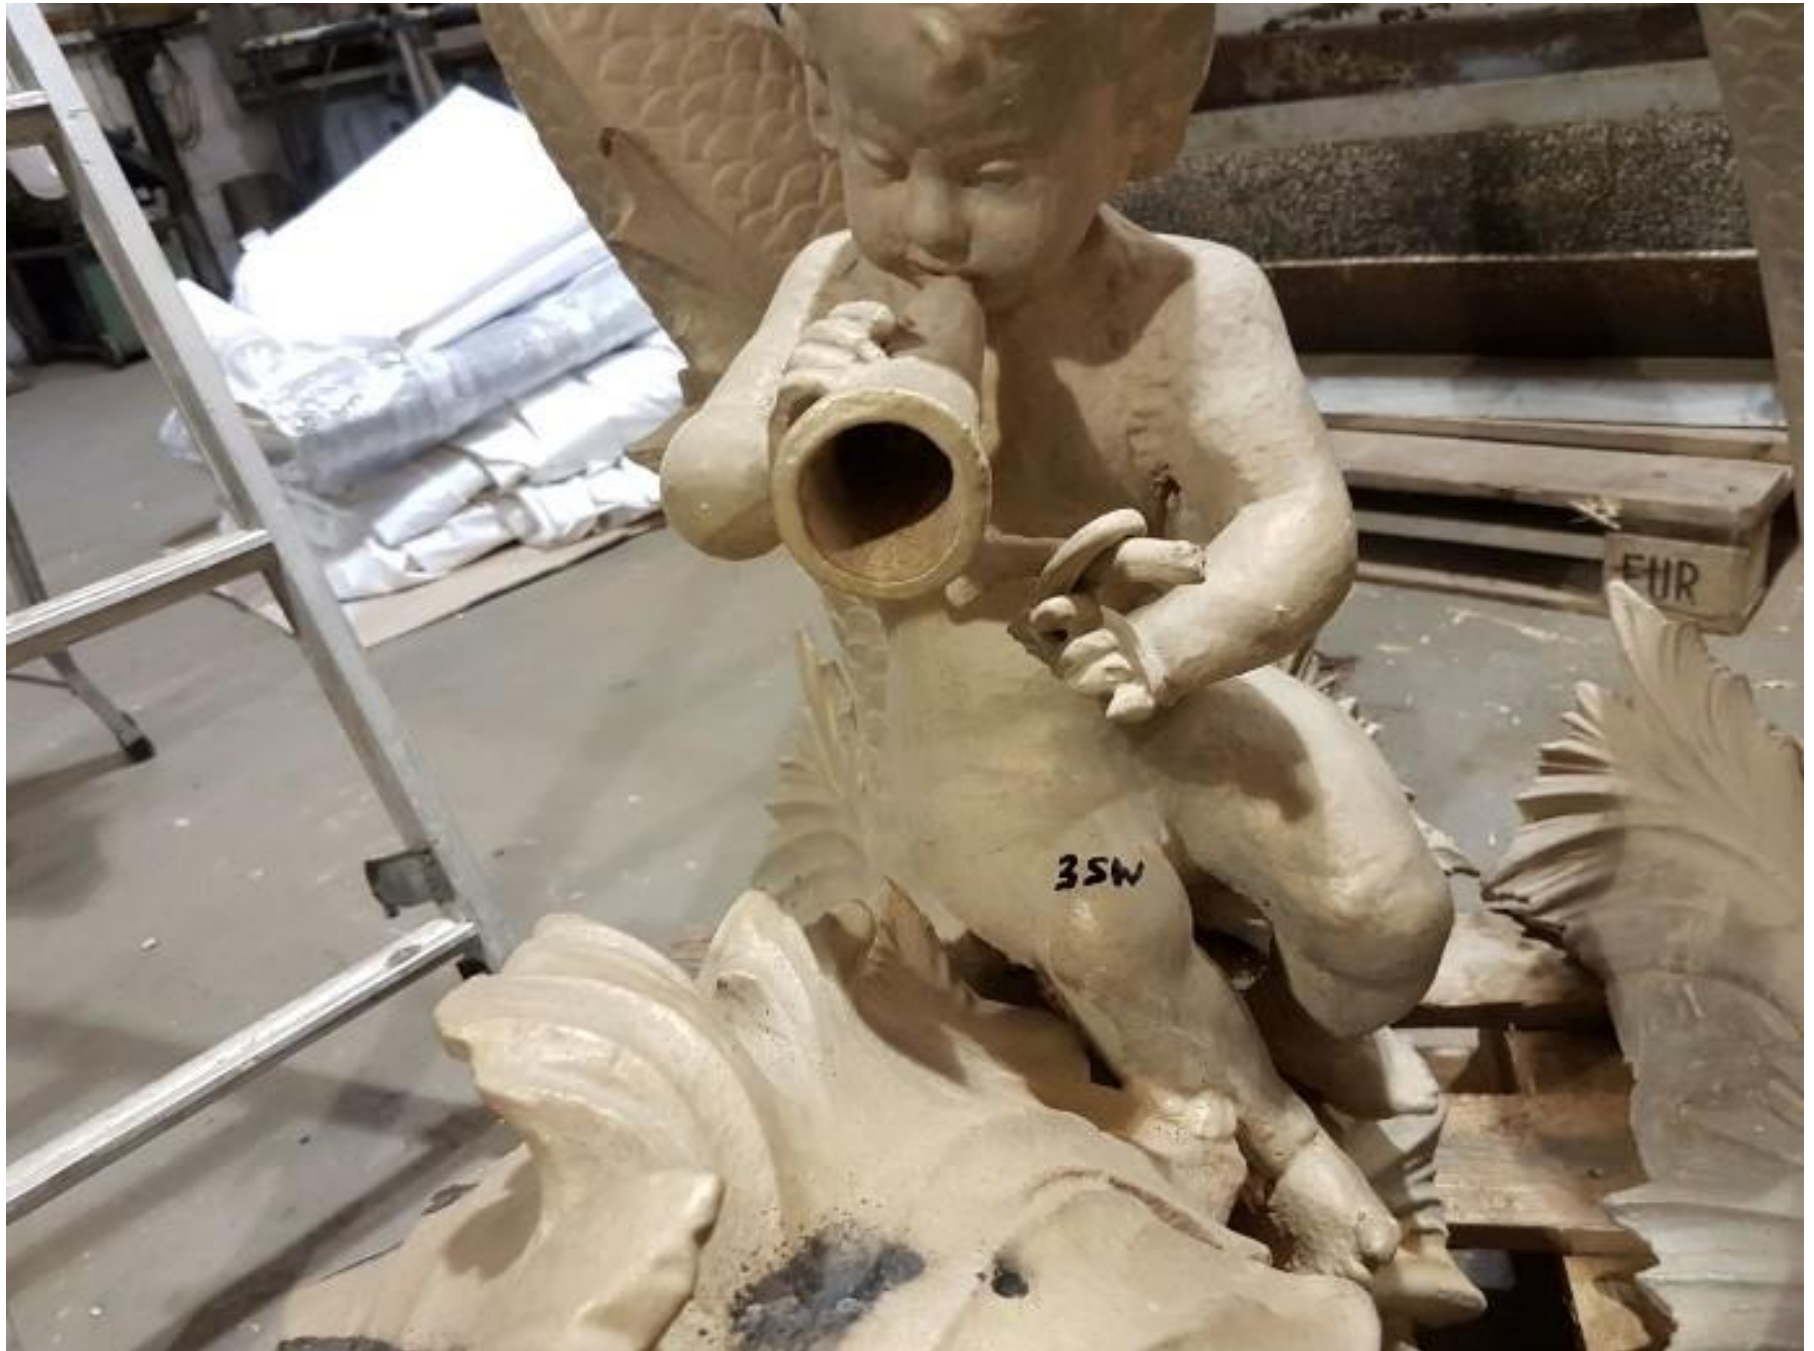
Koi Carp No.3

Decorative Plinth	4	Good	Cleaning & repainting only	
Koi Carp	1	Good	Cleaning & repainting only	
Koi Carp	2	Koi in good condition but internal pipework is loose or broken in the horn decoration	Cleaning & repainting only	See general note No.6 Internal Pipework
Koi Carp	3	Missing Reins completely	Replace Reins	
Koi Carp	4	Missing Bottom part of one rein. Crack on underside of Cherub.	Replace Reins	
Koi Carp	4	Crack on underside of Cherub	Repair crack	
Central Pillar		Lugs were removed in order to remove pillar from granite	Reinstate lugs	
Central Pillar Screen	1	Good	Cleaning & repainting only	Apart from the removal of the curved access door, the central Pillar remains intact. Newton Forge recommend that the central pillar remains intact because further disassembly may cause irreparable damage to an
Central Pillar Screen	2	Good	Cleaning & repainting only	
Central Pillar Screen	3	Good	Cleaning & repainting only

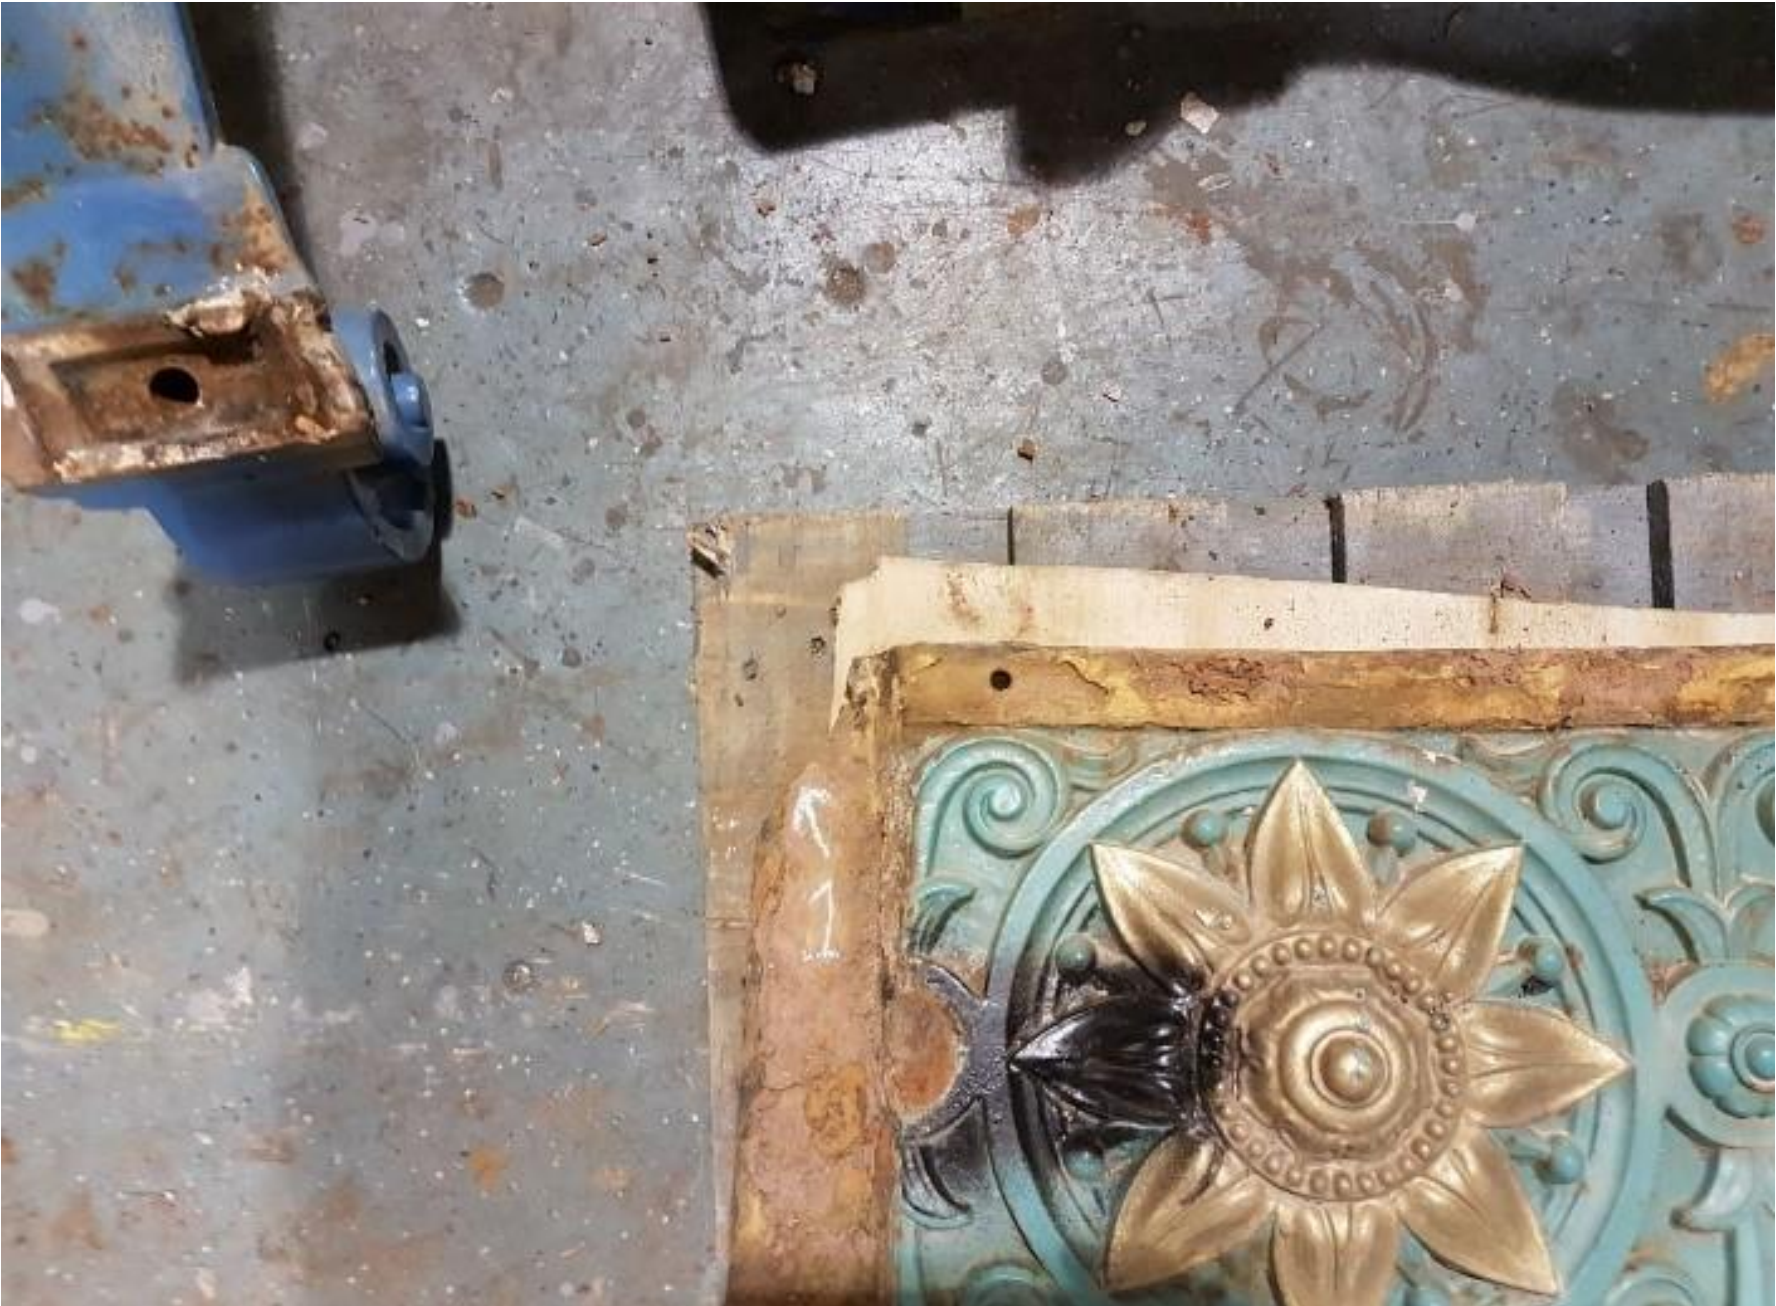
Outer Ring Plate No.1

Component Name	Component ID No.	Condition	Recommended Action	Comments
<b>Pool at Ground Level</b>				
Outer Ring Plate	1	Left hand top corner; underlap - piece missing	Replace missing piece to make good	
Outer Ring Plate	2	Good	Cleaning & repainting only	
Outer Ring Plate	3	Left hand top corner; underlap - piece missing	Replace missing piece to make good	
Outer Ring Plate	4	Good	Cleaning & repainting only	
Outer Ring Plate	5	Good	Cleaning & repainting only	
Outer Ring Plate	6	Good	Cleaning & repainting only	
Outer Ring Plate	7	Good	Cleaning & repainting only	
Outer Ring Plate	8	Good	Cleaning & repainting only	
Outer Ring Plate	9	Good	Cleaning & repainting only	
Outer Ring Plate	10	Crack on Inside	Repair of Crack	
Outer Ring Plate	11	Large crack running through middle of casting	Repair of Crack	
Outer Ring Plate	12	Top left Corner Missing	Replace missing piece	
Outer Ring Plate	13	Good	Cleaning & repainting only

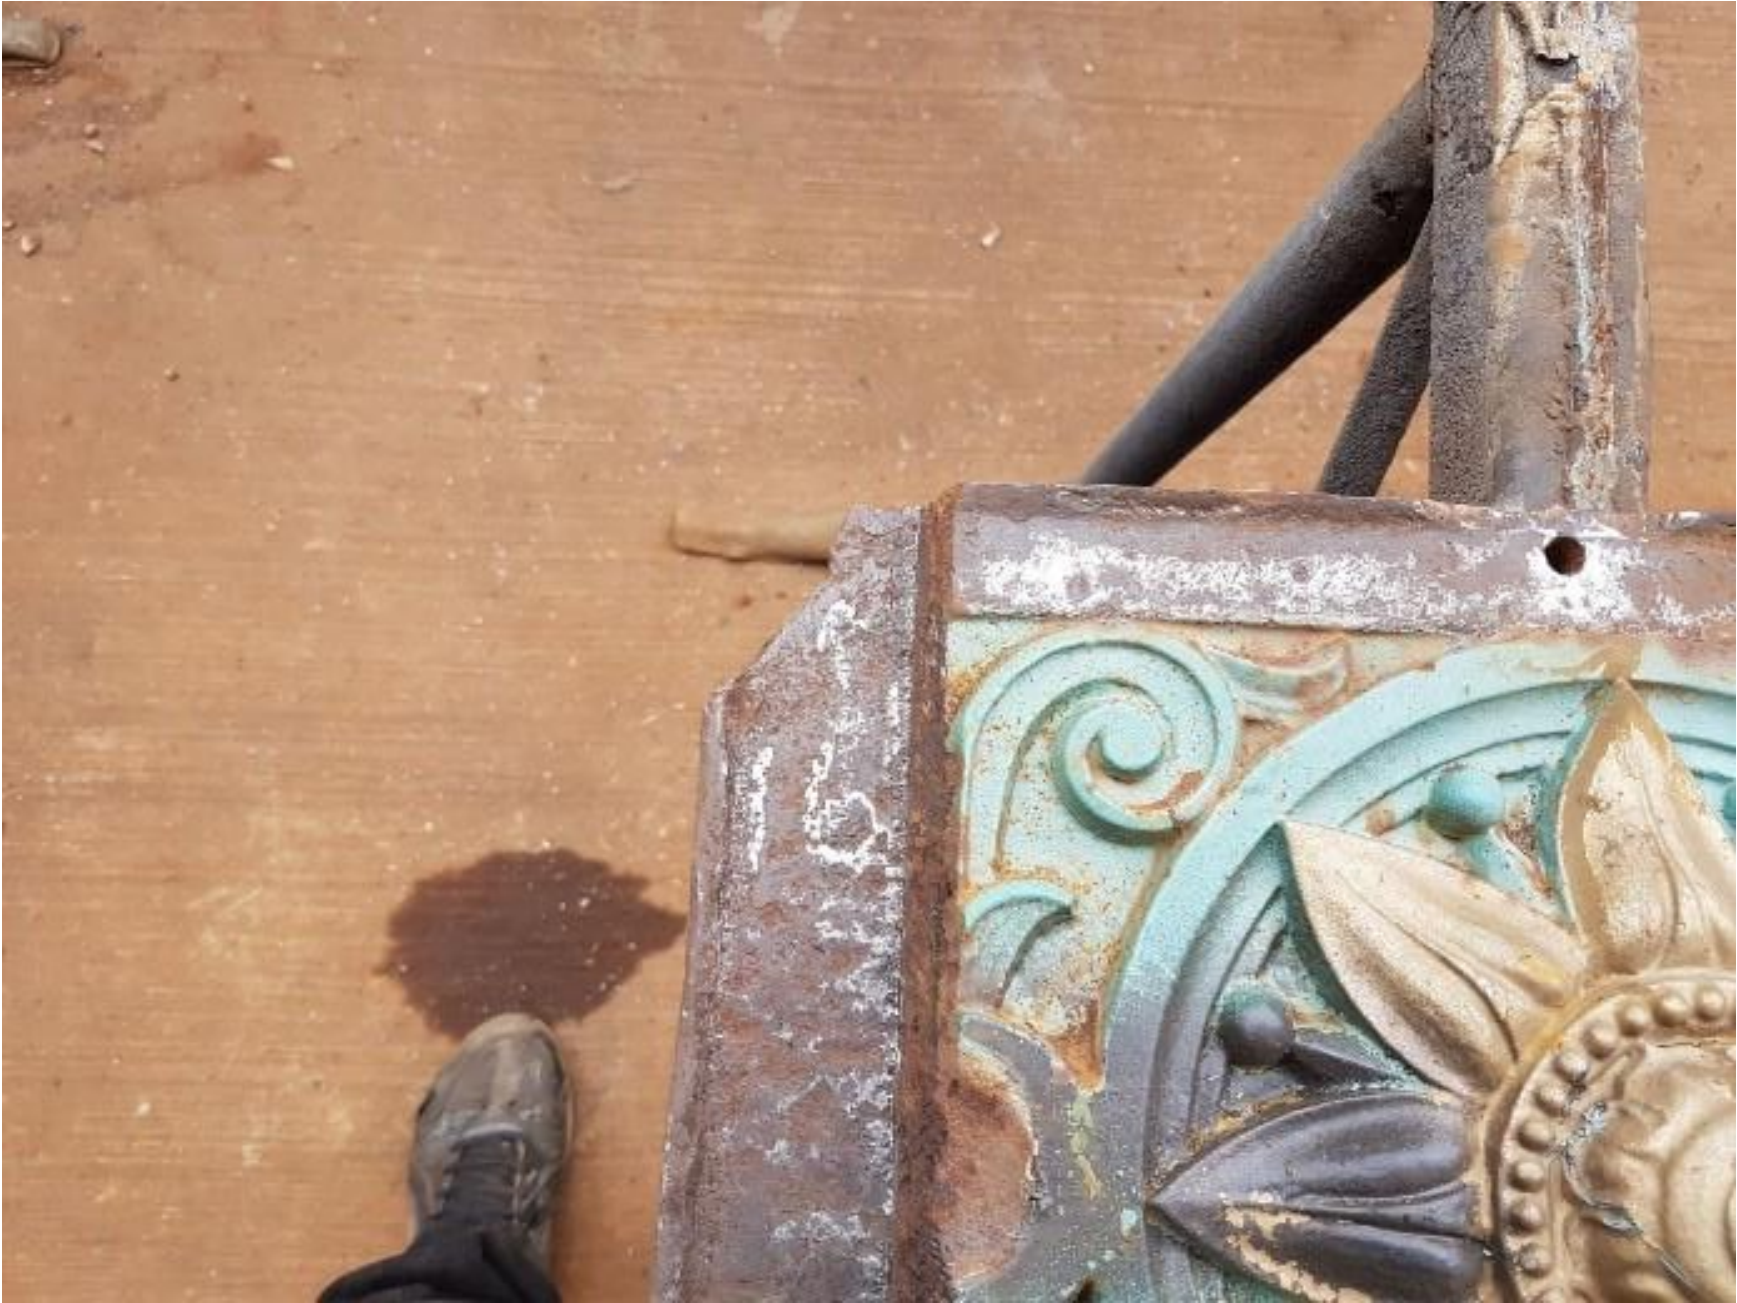
Outer Ring Plate No.16

Outer Ring Plate	14	Good	Cleaning & repainting only	
Outer Ring Plate	15	Good	Cleaning & repainting only	
Outer Ring Plate	16	Top Left corner underlap- piece missing	Replace missing piece and Repair hole	
Outer Ring Plate	17	Good	Cleaning & repainting only	
Outer Ring Plate	18	Good	Cleaning & repainting only	
Outer Ring Plate	19	Lug missing on bottom. Lug was cut off onsite to remove	Replace Lug	
Outer Ring Plate	20	Top Left corner underlap- piece missing	Replace missing piece and Repair hole	
Outer Ring Plate	21	Large crack running through middle of casting - Full penetration	Repair Crack	
Outer Ring Plate	22	Good	Cleaning & repainting only

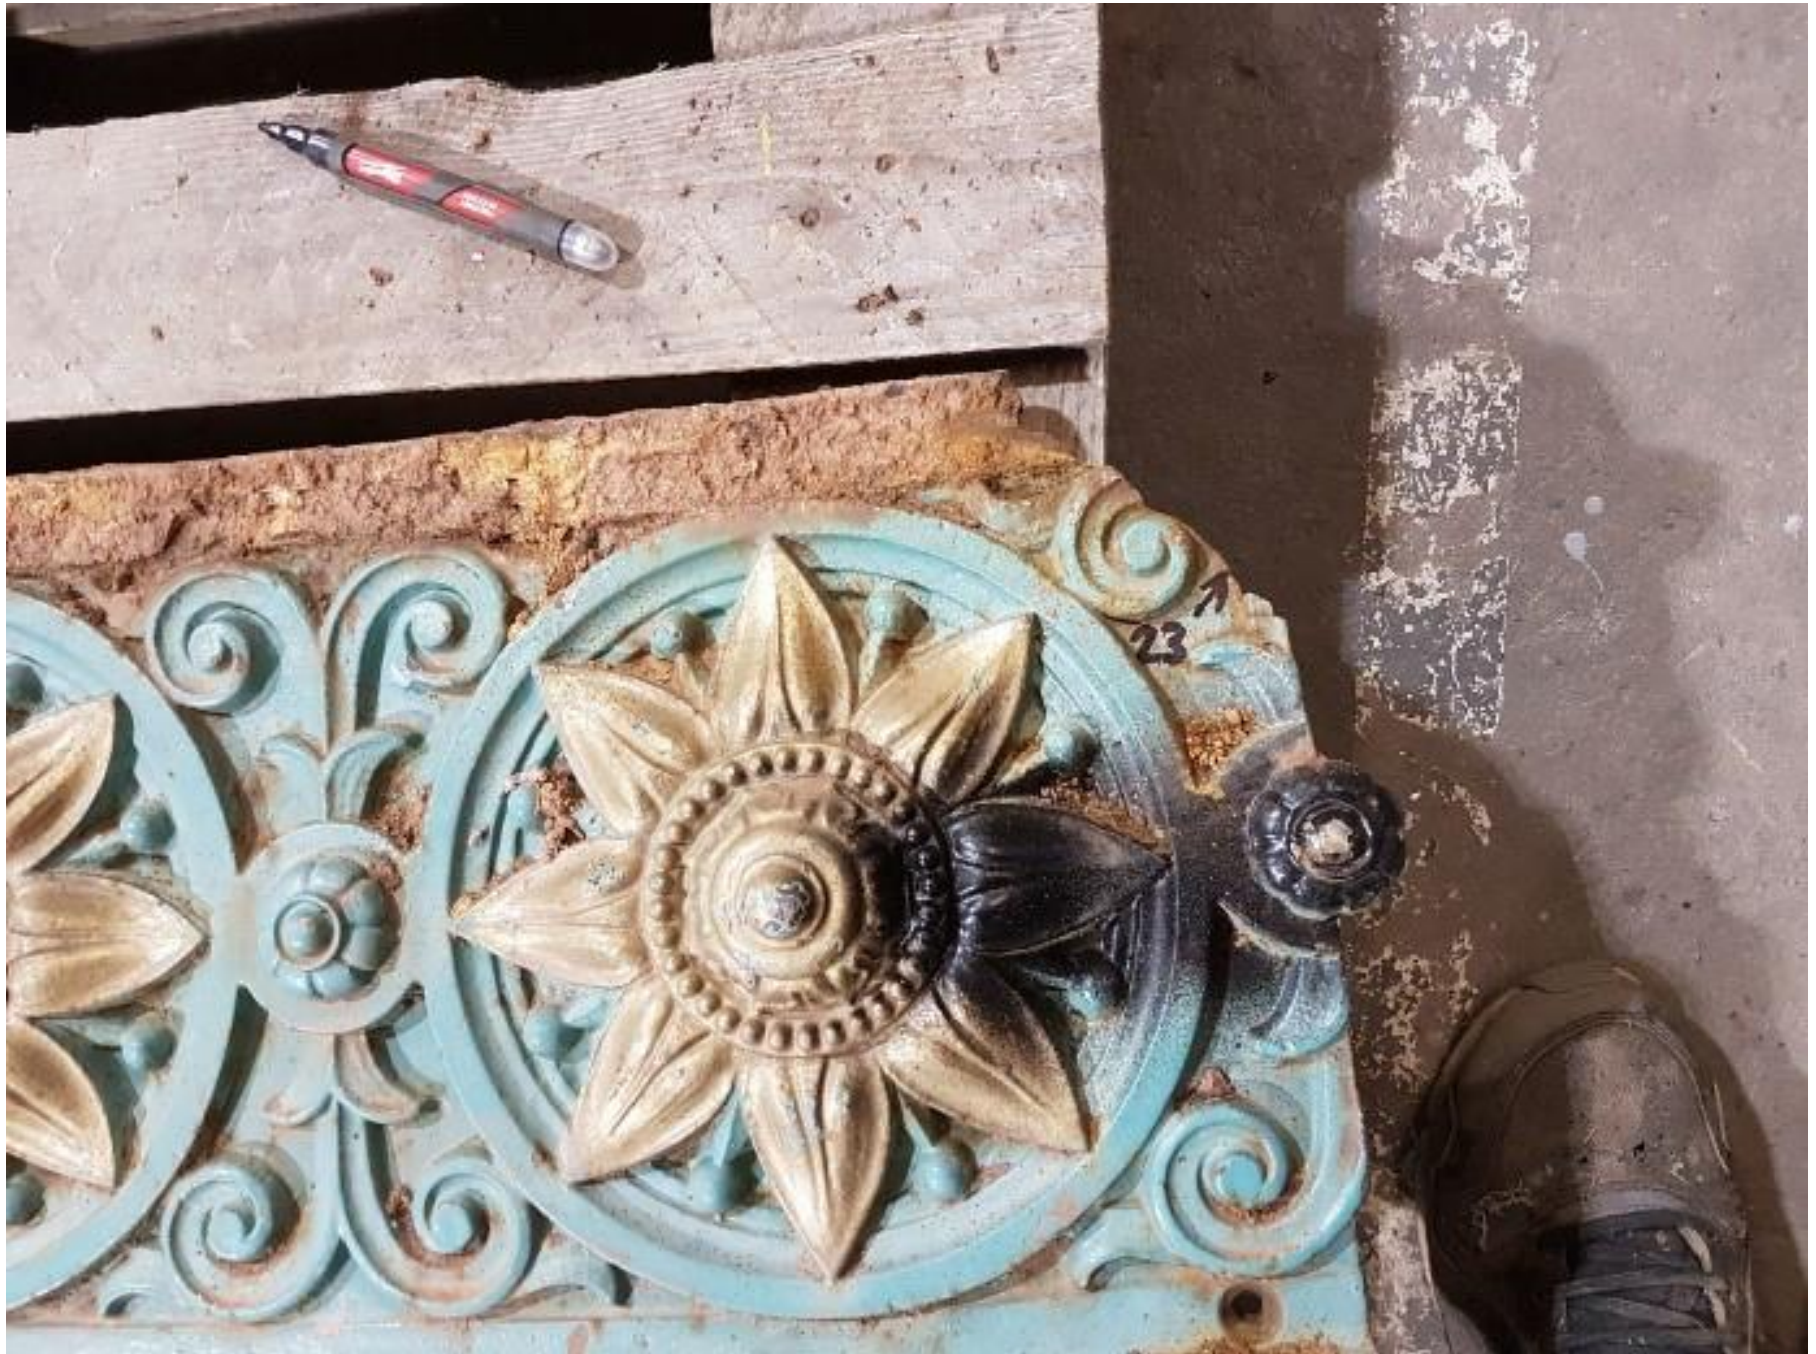
Outer Ring Plate No.23

Component Name	Component ID No.	Condition	Recommended Action	Comments
Outer Ring Plate	23	Top Right corner Overlap-piece broken off - Extensive enough to include a portion of the decoration	Replace Corner and reinstate decoration	
Outer Ring Cap	1	2 Large Cracks - Left hand side Foundry Plate intact	Repair of Crack	
Outer Ring Cap	2	Good	Cleaning & repainting only	
Outer Ring Cap	3	Good	Cleaning & repainting only	
Outer Ring Cap	4	Good	Cleaning & repainting only	
Outer Ring Cap	5	Good	Cleaning & repainting only	
Outer Ring Cap	6	Good	Cleaning & repainting only	
Outer Ring Cap	7	Good	Cleaning & repainting only	
Outer Ring Cap	8	Foundry Plate broken in 2 places	Replace Foundry Plate	
Outer Ring Cap	9	Good	Cleaning & repainting only	
Outer Ring Cap	10	Good	Cleaning & repainting only	
Outer Ring Cap	11	Good	Cleaning & repainting only	
Outer Ring Cap	12	Good	Cleaning & repainting only	
Outer Ring Cap	13	Good	Cleaning & repainting only
