# PRINCESS GARDENS FOUNTAIN TORQUAY

**Condition Report – January 2018**

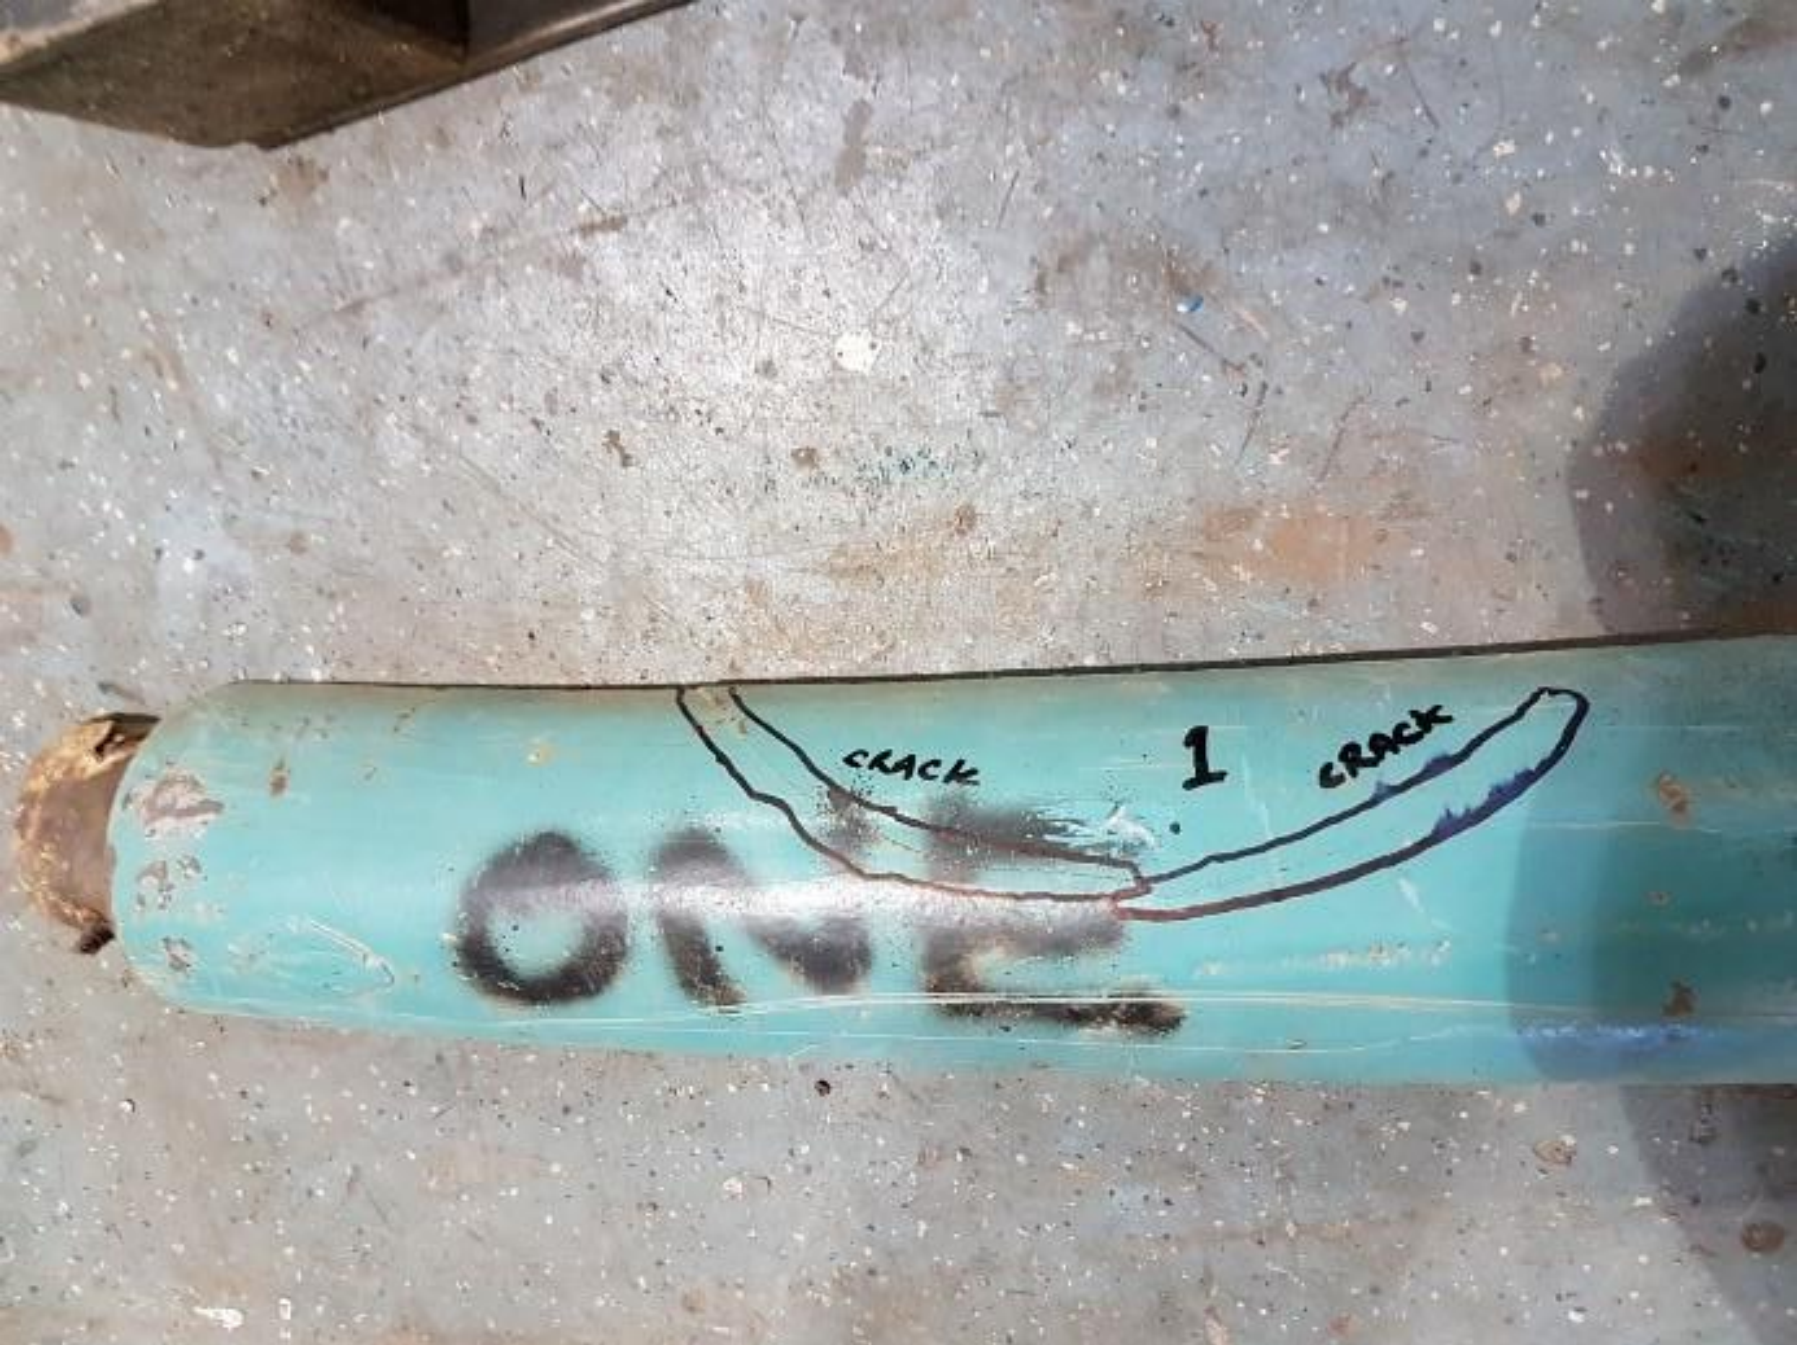
Outer Ring Cap No.1

Component Name	Component ID No.	Condition	Recommended Action	Comments
Outer Ring Plate	23	Top Right corner Overlap-piece broken off - Extensive enough to include a portion of the decoration	Replace Corner and reinstate decoration	
Outer Ring Cap	1	2 Large Cracks - Left hand side Foundry Plate intact	Repair of Crack	
Outer Ring Cap	2	Good	Cleaning & repainting only	
Outer Ring Cap	3	Good	Cleaning & repainting only	
Outer Ring Cap	4	Good	Cleaning & repainting only	
Outer Ring Cap	5	Good	Cleaning & repainting only	
Outer Ring Cap	6	Good	Cleaning & repainting only	
Outer Ring Cap	7	Good	Cleaning & repainting only	
Outer Ring Cap	8	Foundry Plate broken in 2 places	Replace Foundry Plate	
Outer Ring Cap	9	Good	Cleaning & repainting only	
Outer Ring Cap	10	Good	Cleaning & repainting only	
Outer Ring Cap	11	Good	Cleaning & repainting only	
Outer Ring Cap	12	Good	Cleaning & repainting only	
Outer Ring Cap	13	Good	Cleaning & repainting only

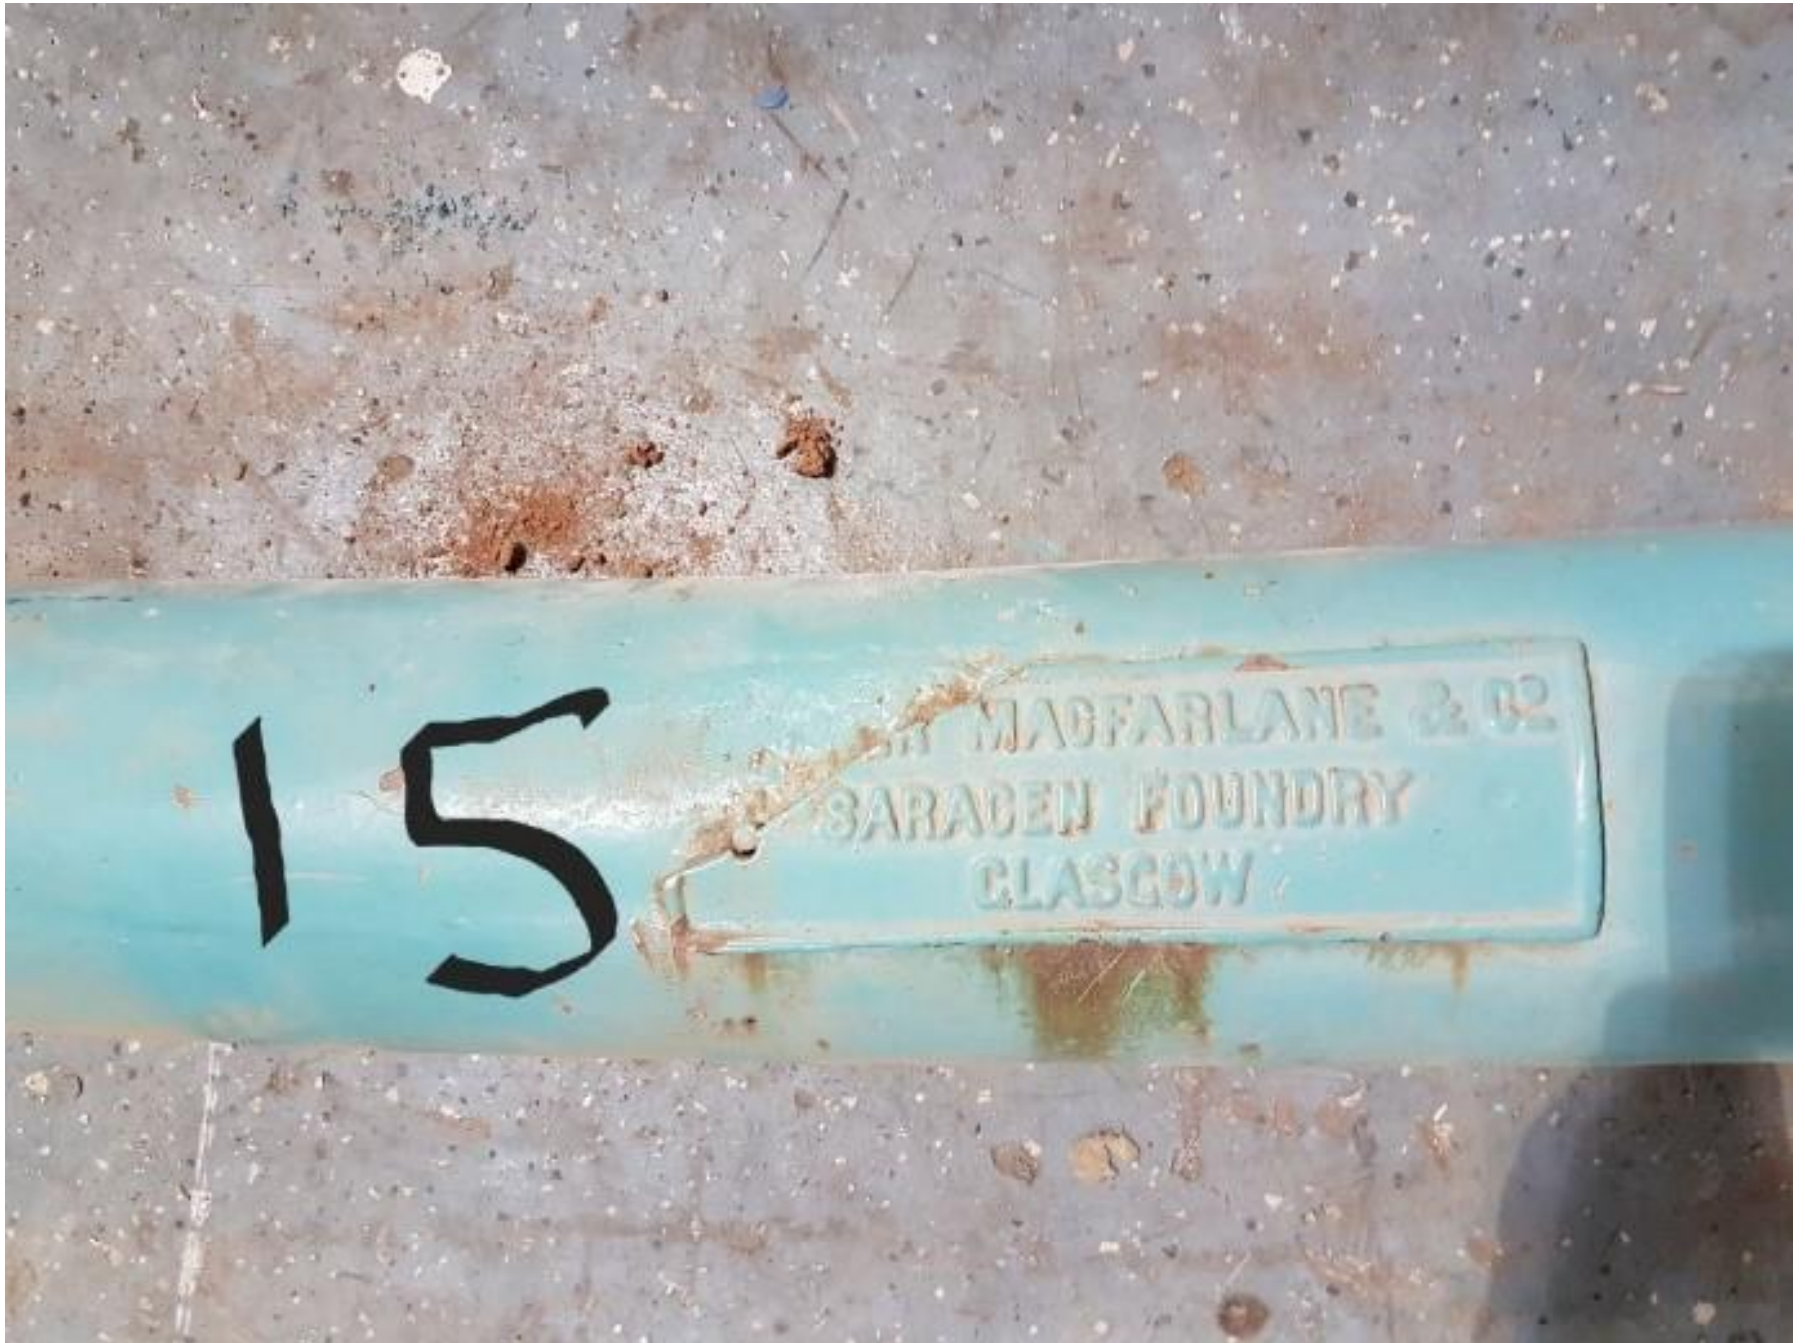
Outer Ring Cap No.15

Outer Ring Cap	14	Good	Cleaning & repainting only	
Outer Ring Cap	15	Foundry Plate broken in 2 places	Replace Foundry Plate	
Outer Ring Cap	16	Good	Cleaning & repainting only	
Outer Ring Cap	17	Underlap Joint broken and piece is missing	Replace missing piece and Repair hole	
Outer Ring Cap	18	Good	Cleaning & repainting only	
Outer Ring Cap	19	Good	Cleaning & repainting only	
Outer Ring Cap	20	Good	Cleaning & repainting only
