**TORBAY COUNCIL**  
**Flood Investigation Report**  
**27th August 2020**

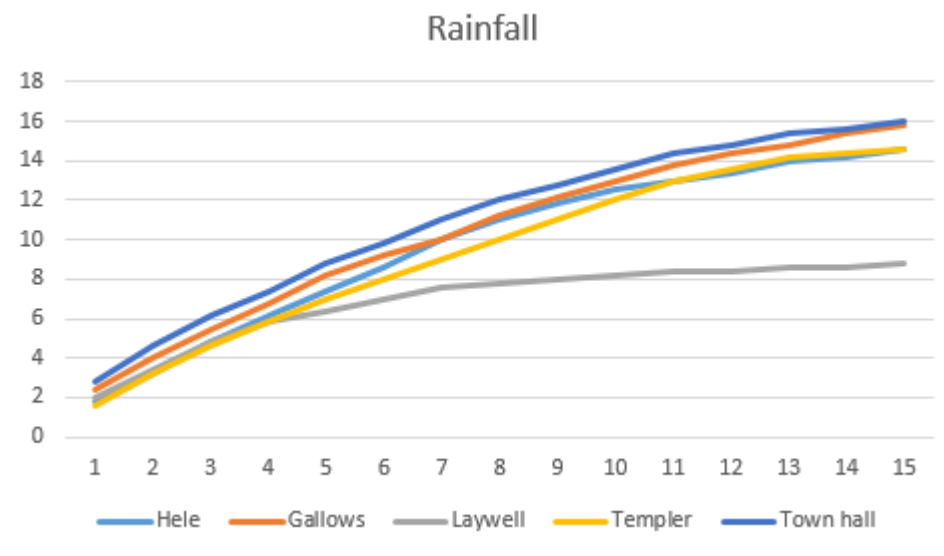
This can be shown graphically as:

Based on the Cockington catchment this equates to a return period of 1 in 15 years.
