Paignton Road Overbridge

Project Overview

Paignton Road A379 – TOR 220m 49.5ch

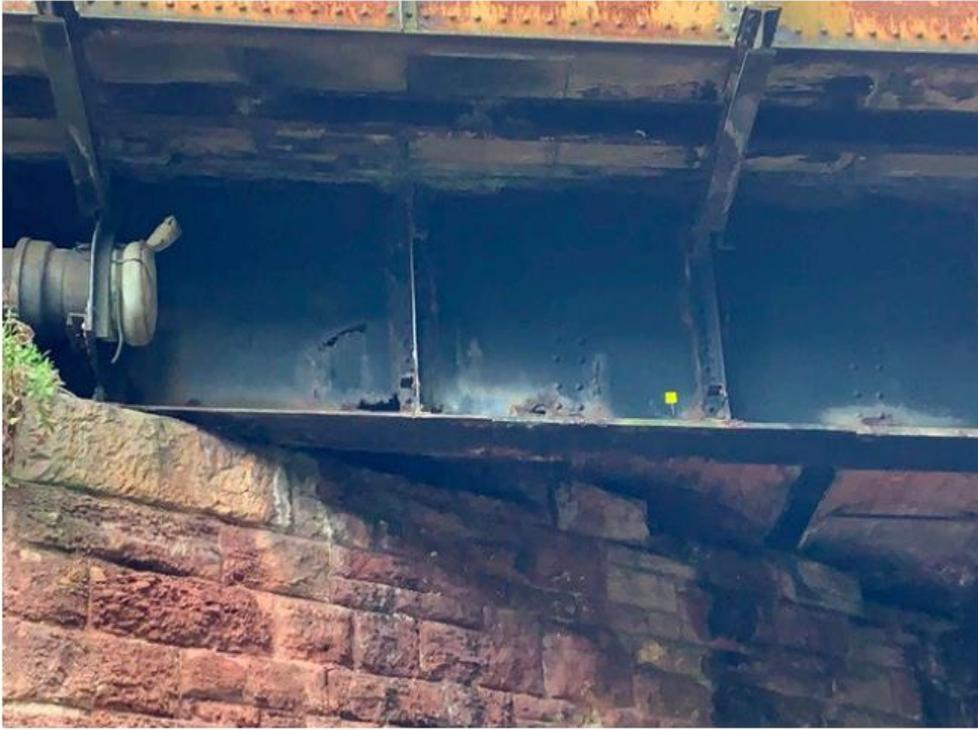
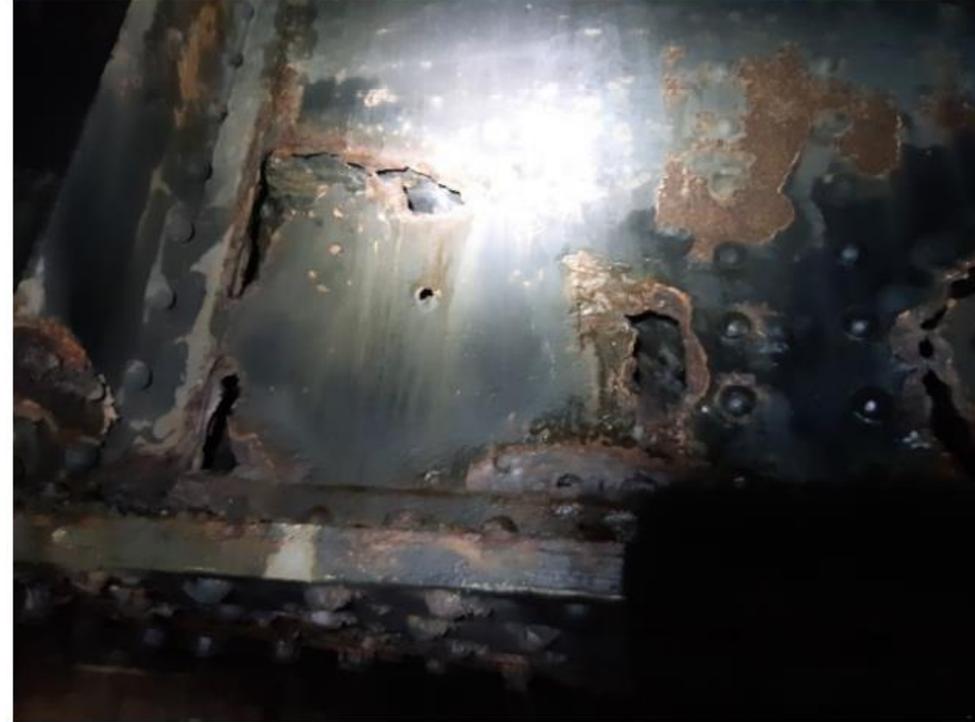
- 3 yearly detailed exam & assessment programme identified accelerated corrosion in the main girders
- Repair solution - Form of construction
- Replacement – Whole Life Cost Solution

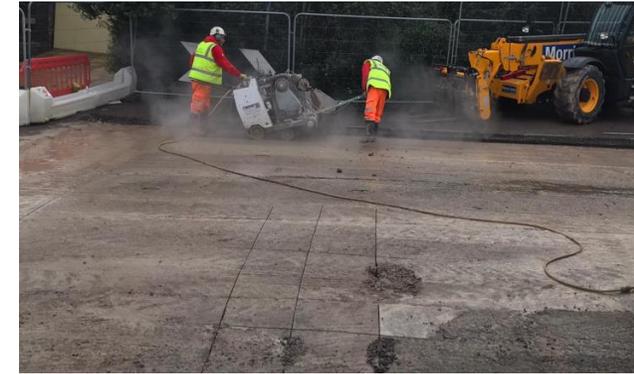
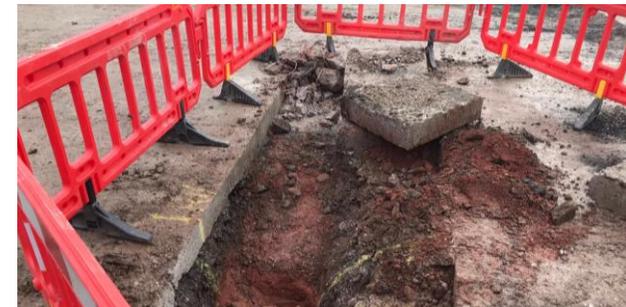
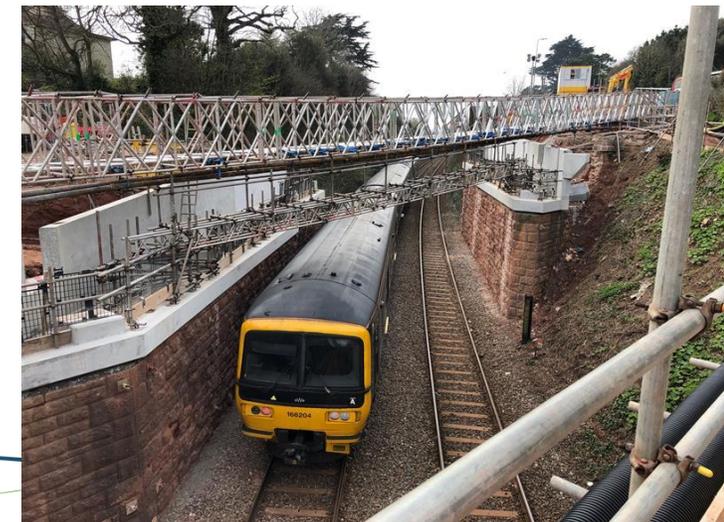
Working around the critical BT cables

The BT cables were encased in concrete and needed to be excavated by hand which took in excess of four weeks to complete.

The cables required a temporary support structure to suspend them from which made the installation of the new bridge beams far more difficult than originally planned

Due to the cables still being in the road the demolition sequence had to change which prolonged the programme and the team were unable to demolish the bridge in the original railway closure requiring further access to complete

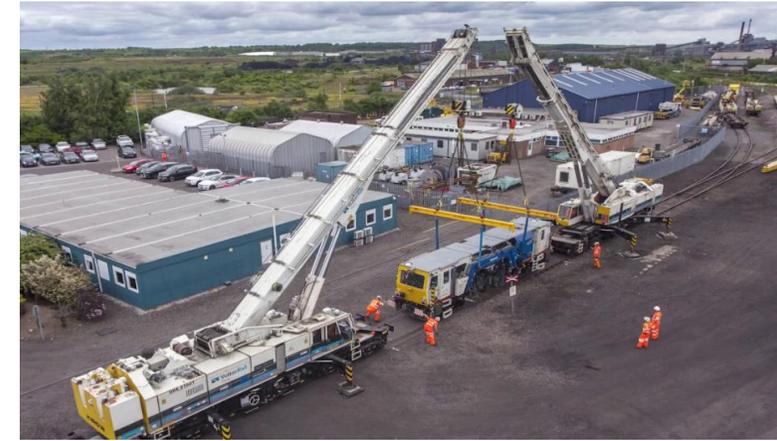
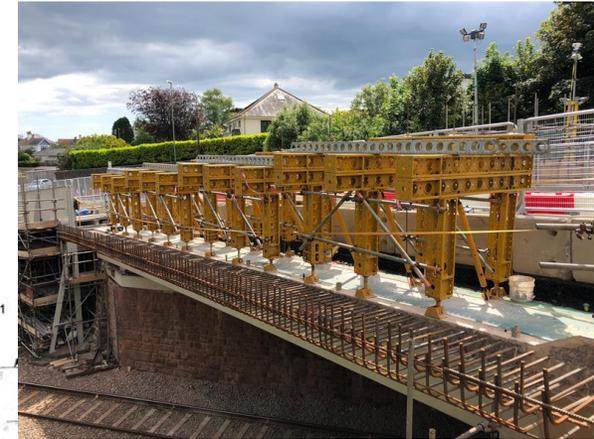
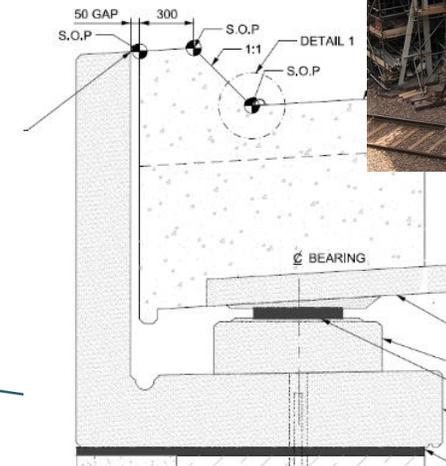
As the cables needed to remain in-situ with minimal movement we were required to make design changes to the cill units that the bridge beams are landed on. These were already cast and required specialist hydro demolition techniques and subsequent reinforcement changes

Changes to the lifting sequences needed to be made for the cill beams to install beneath the BT cables

The bridge beams needed to be installed over nights during the week due to missed railway access this further compounded the delays as there is only a 5hr working window most nights.

The requirement to open the road on the 23 May changed the construction sequence of the bridge deck requiring us to make further design changes to the parapet units moving from a precast solution to an in-situ solution. This required further design changes to the reinforcement detail and delayed the completion of the works
