Report No.	Date.
WB03590 R2	November 2016

Project
Whiterock Urban Extension

Client Name
Deeley Freed Estates Limited

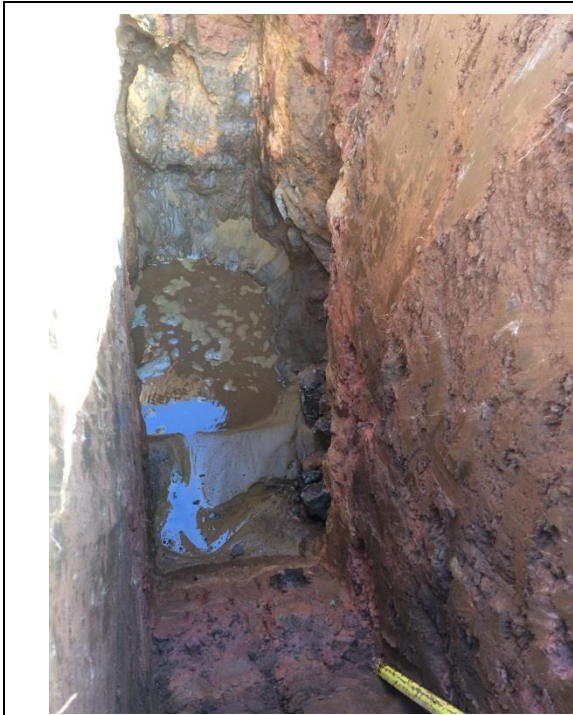
Plate 5 – TP3 showing the water running into a fissure in the bottom right hand corner

TP3 encountered a layer of boulders of limestone between 1.3m and 2.2m depth. Amongst the boulders were highly variable pockets of soft black silt, orange silty clay and white ashy silt. TP8 encountered similarly variable materials between 1.6m to the final depth of 2.5m. The black material is likely to be umber (volcanic ash deposit) and it is this material that has been washed out between limestone horizons elsewhere in the Whiterock area.

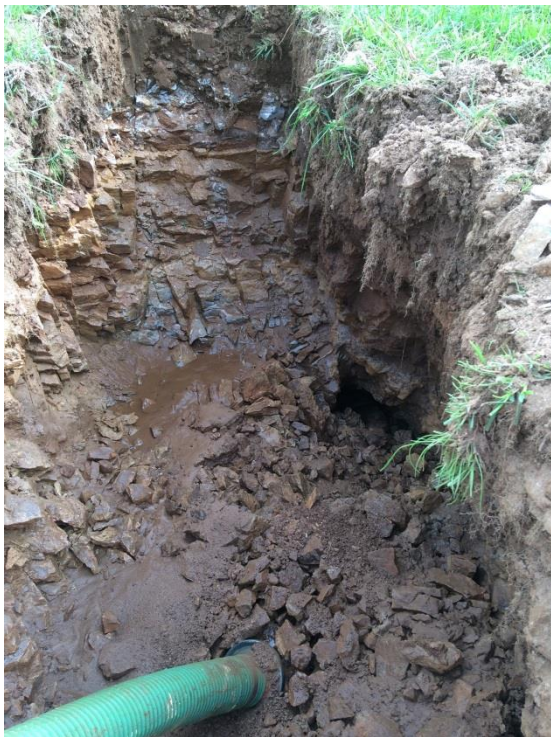
Plate 19 – TP9 showing the fissure in the base

*The soakaways in TP3 and TP9 did not yield typical results due to the opening of fissures in the base of the pits. TP3 opened up during the course of the first fill. TP9 underwent two full standard soaks, however during the third fill a fissure opened in the base of the pit, causing a sudden emptying of the water. Photos of this fissure are shown on Plates 19 -20 in Appendix B.
